US-191/MT-64 Wildlife & Transportation Assessment

KEY FINDINGS

Overview

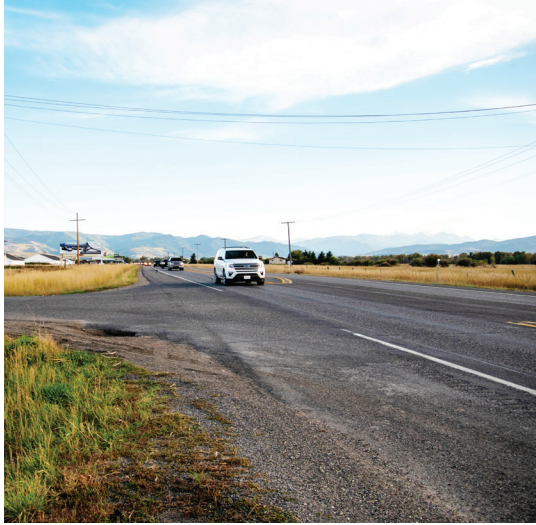
Four Corners to Gallatin Gateway

Bordered by homes and businesses, this site has high wildlife-vehicle collision risk and very high traffic volume in an area of increasing development. The presence of many secondary roads, access roads, and driveways—along with lack of land use planning—limits the potential for mitigation measures to reduce collision risk and maintain habitat connectivity. Traffic volume is nearing the threshold at which roads may serve as complete barriers to wildlife (average daily traffic > 15,000 vehicles).^e As a result, fewer animals will attempt cross the road, and those that do will face an elevated collision risk.

- Consider use of seasonal warning signs, which may marginally reduce collisions.
- Consider the potential of alternative modes of transportation, such as ride sharing, and elements of intelligent transportation systems (e.g., timed traffic signal controls and warning signs). These may also marginally reduce collisions.
- Evaluate the South Cottonwood Creek culvert for the addition of a dry shelf to accommodate small- to medium-bodied terrestrial wildlife, even during higher flows.

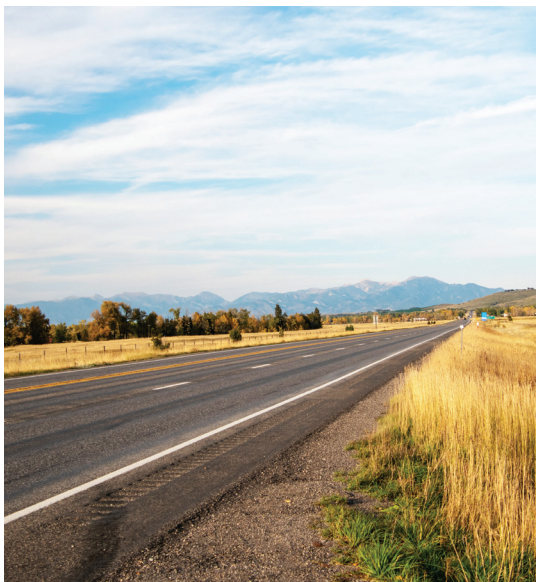
Gallatin Gateway to Spanish Creek

At this site, high wildlife-vehicle collision risk and high traffic volume occur in a landscape of mixed agricultural and residential land uses (to the north), and larger upland parcels that lead to the Custer Gallatin National Forest along the mouth of the Gallatin Canyon (to the south).

- Retrofit the bridge over the Gallatin River to accommodate large mammals by developing pathways beneath that offer secure footing and sufficient vertical clearance as an interim measure until replacement by an enlarged structure designed for safe wildlife passage; construct fencing to keep wildlife off the road and guide them to the structure.

- Replace the Spanish Creek Bridge with a structure that spans the entire riparian area, has sufficient height (> 15 ft) to allow suitable dry passage beneath for large mammals year-round, and includes fencing to keep wildlife off the road and guide them to the structure.

- Have land trusts explore the potential for land security through voluntary conservation easements with landowners in the vicinity of Mile Posts 70.5-73; examine the engineering feasibility of an overpass with fencing.

- If the measures are implemented, evaluate connecting the structures via fencing and upsizing an existing culvert to better accommodate small- to medium-bodied terrestrial wildlife and aquatic species.

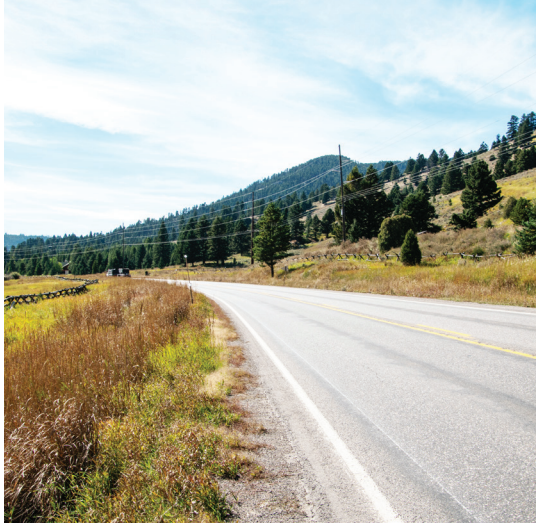
North of Big Sky Entrance

With elevated traffic volume, this area has a growing risk of wildlife-vehicle collisions and is becoming a barrier to wildlife movement. Elk frequently cross the highway along each of the 0.10-mile segments within the site—bordered by parcels that lead to the Custer Gallatin National Forest and Lee Metcalf Wilderness Area—and bighorn sheep are often observed along the road. Both species are documented in wildlife-vehicle collisions.

- Retrofit the Jack Smith Bridge over the Gallatin River to accommodate large mammals by developing a pathway that offers secure footing beneath. This would serve as an interim measure until replacement by an enlarged structure designed for safe wildlife passage.
- Have land trusts explore the potential for land security through voluntary conservation easements with landowners west of the road on undeveloped parcels; examine the engineering feasibility of an overpass with fencing, which could connect to the bridge following retrofitting or replacement.

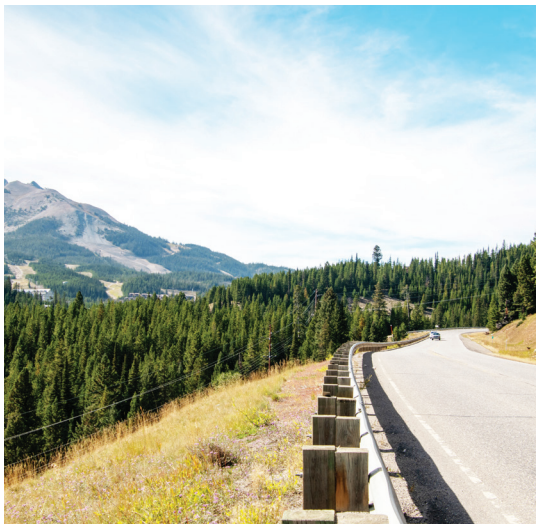
Located on steep slopes at high elevation, the Upper Big Sky Connectivity Area is aptly named for its importance for alpine species, including wolverines. With relatively low traffic and lower-speed travel than other sites, and complex topography and steep roadway grades, no structural measures are recommended at present. However, as development and traffic volume increase, monitoring is recommended to evaluate trends and identify future opportunities to maintain regional connectivity and reduce wildlife-vehicle collisions.

- Monitor the area for changes in development and traffic pressure, as well as for wildlife-vehicle collisions.

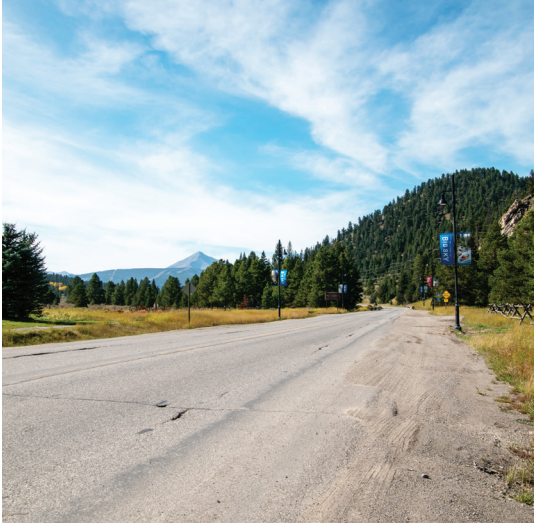
West Fork Gallatin

At this site located just west of the turn-off onto MT-64 (Lone Mountain Trail) to Big Sky, bighorn sheep frequent the steep slopes of the Custer Gallatin National Forest north of the road, while elk often graze in meadows on the south side. Due to a fairly high traffic volume and the fidelity of these species to preferred habitats on either side of the road, measures to reduce collisions are a primary focus. Two existing structures—a small bridge at Mile Post 0.2 and a culvert at Mile Post 1.1—may allow for passage by species such as black bears, mountain lions, coyotes, bobcats, lynx, and wolverines, but do not have sufficient clearance for passage by elk or other large mammals.

- Evaluate a combination of animal detection systems, traffic-calming measures (e.g., roundabouts or other physical changes), and exclusionary fencing between existing structures to reduce wildlife-vehicle collisions.
- Replace the culvert at Mile Post 1.1 with a larger structure or a span bridge suitable for passage beneath by a wider range of species, including deer and black bears.

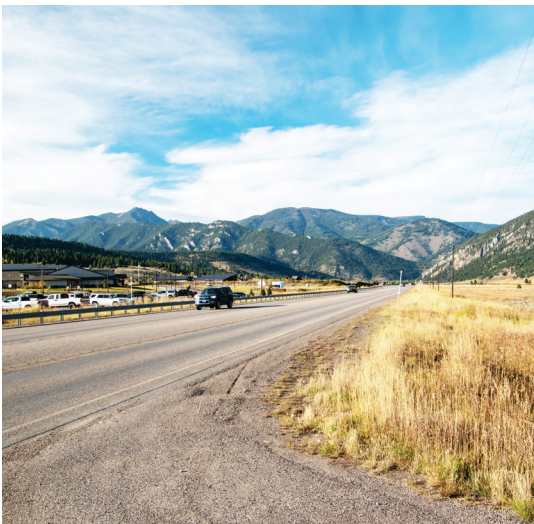
Bordered by the Gallatin Wildlife Management Area and the Custer Gallatin National Forest, this site hosts high concentrations of elk and other wildlife year-round, with Porcupine and Beaver Creeks serving as major movement corridors between the Gallatin and Madison Ranges.

- Consider designs for traffic-calming measures such as roundabouts, rumble strips, new pavement markings, or other physical changes to slow traffic and allow posting of lower speed limits. In addition, explore the possibility of motion-activated, nighttime lighting, especially along the more developed extent of the site, from the vicinity of Porcupine Creek to the north.
- Evaluate the Beaver Creek culvert for upsizing to better accommodate small- to medium-bodied terrestrial wildlife, along with aquatic species.
- Have land trusts explore the potential for land security through voluntary conservation easements with landowners west of the road (in the less developed southern extent of the site); examine the engineering feasibility of an overpass with fencing, along with animal detection systems at fence ends.

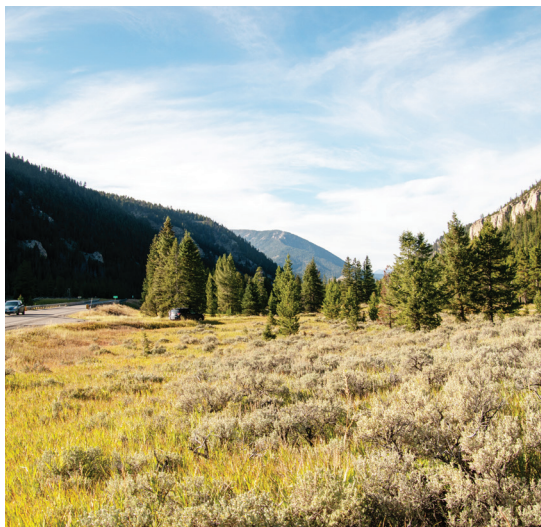
Primarily surrounded by the Custer Gallatin National Forest, the Taylor Fork is a significant tributary of the Gallatin River that serves as a major movement corridor between the Gallatin and Madison Ranges. Road crossings by elk are documented in each of the fifteen 0.1-mile road segments within the site, with grizzly bear crossings documented in five of the segments. Wildlife-vehicle collisions involving elk, moose, deer, pine martens, and a grizzly bear are also documented.

- Replace the Taylor Fork Bridge with a structure that spans the full extent of the riparian area and has sufficient height (> 15 ft) to allow suitable dry passage beneath for large mammals year-round. Evaluate the need for fencing.
- Evaluate the culvert immediately south of Mile Post 36 for upsizing to better accommodate small- to medium-bodied terrestrial wildlife, along with aquatic species.

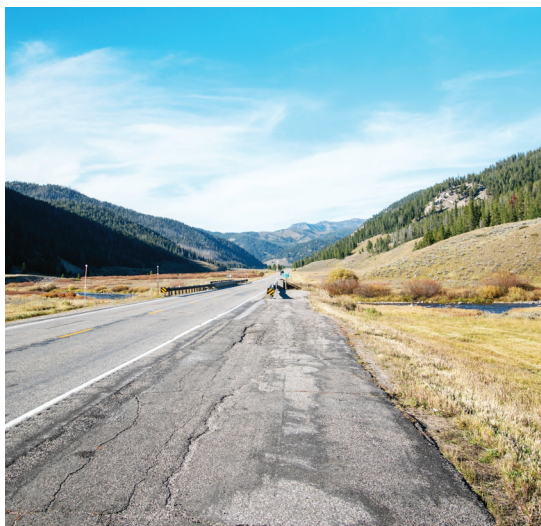
Specimen Creek to Bacon Rind Creek

Encompassed within Yellowstone National Park, this site is characterized by open riparian meadows along the roadside rising to forested slopes, including the Lee Metcalf Wilderness Area to the west. Frequent road crossings by elk and grizzly bears are documented, along with wildlife-vehicle collisions involving elk, moose, deer, bighorn sheep, black bears, wolves, coyotes, foxes, pine martens, and beavers.

- Replace the Gallatin River and Specimen Creek Bridges with structures that span the full extent of the riparian area of each water body and have sufficient height (> 15 ft) to allow suitable dry passage beneath for large mammals year-round.
- Evaluate five existing culverts for upsizing for use by aquatic and small- to medium-sized terrestrial wildlife.
- Consider connecting the upgraded structures together via fencing to reduce wildlife-vehicle collisions and to guide wildlife. A possible alternative may be an animal detection system(s).
- Examine the potential for management of the highway as a “park road” rather than throughway, including night closure to semi-trucks.

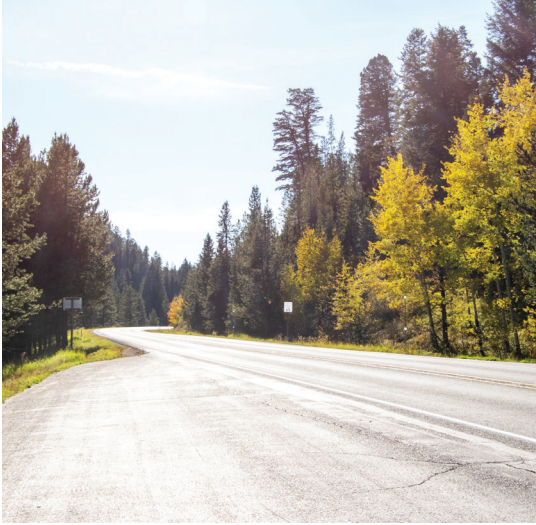
Connecting Yellowstone National Park and the Custer Gallatin National Forest, this site provides habitat for elk, moose, and grizzly bears, among other species, in a mix of forest, wetland, and riparian areas. As traffic volume increases, measures to maintain habitat connectivity are critical. Wildlife-vehicle collisions with three grizzly bears, plus elk, moose, coyotes, foxes, pine martens, beavers, and porcupines are documented.

- Replace the Grayling Creek Bridge with a structure that spans the full extent of the riparian area and has sufficient height (> 15 ft) to allow suitable dry passage beneath for large mammals year-round. The adjacent snowmobile bridge would require similar enlargement.
- Replace the double pipe culverts at Teepee Creek with a structure that spans the full extent of the wetland and riparian areas and has sufficient clearance (> 15 ft) to allow large mammals to pass beneath.
- Following these changes, consider connecting the new structures via fencing, which may extend as far south as Fir Ridge.

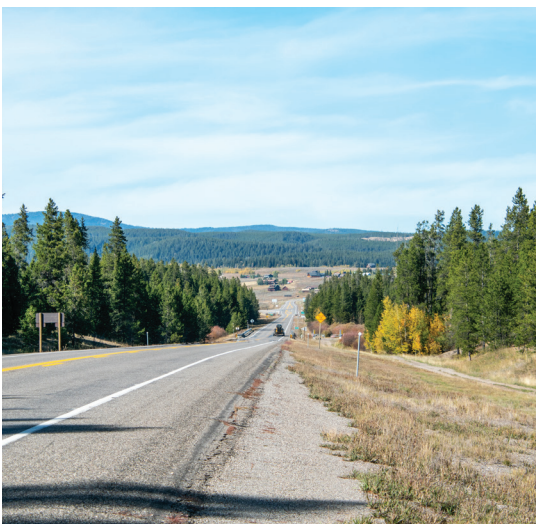
Located largely within the Custer Gallatin National Forest in an area of forest and meadows with high wildlife density based on proximity to Yellowstone National Park, the Cougar/Duck Creek site is highly valuable for habitat connectivity for multiple species. A significant number of collisions with bison also occur at the site based on recent data, as well as in a 2012 analysis carried out independently by MSU's Western Transportation Institute.^m

- Consider options for replacing the existing Cougar Creek Bridge and Duck Creek culvert with structures that span the full extent of the riparian area of each water body and have sufficient height (> 15 ft) to allow suitable dry passage beneath by large mammals year-round. The adjacent snowmobile bridges would require similar enlargement.
- Fencing and fence end treatments such as animal detection systems would also be necessary to direct animals to the structures and to warn drivers of wildlife on the road.

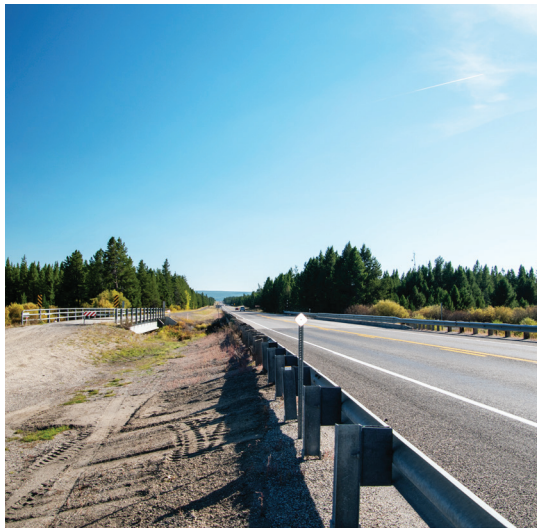
Ensnconced within lodgepole pine habitat at grade with the road within the Custer Gallatin National Forest, this site is in an area of high use by bison and other species just beyond Yellowstone National Park. A significant number of collisions with bison also occur at the site based on recent data, as well as in a 2012 analysis carried out independently by MSU’s Western Transportation Institute.^m

- Consider options for replacing the existing Madison River Bridge with a structure that spans the full extent of the riparian area and has sufficient height (> 15 ft) to allow suitable dry passage beneath by large mammals year-round, and/or consider the feasibility of construction of a dedicated overpass.
- Fencing and fence end treatments such as animal detection systems would also be necessary to direct animals to any structure and to warn drivers of wildlife on the road.
