Technical Guidance: Mojave Desert Tortoise Conservation and Recovery Measures Along Roads

Elizabeth Fairbank¹, Marcel Huijser², and Florence Deffner³

Mojave Desert Tortoise Transportation Ecology Task Force

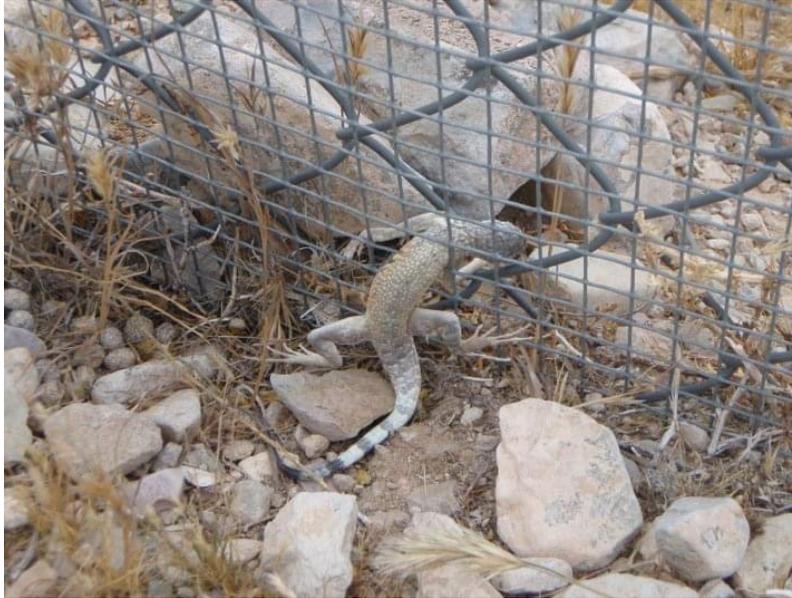
A lizard that got stuck in a fence designed for Mojave desert tortoises, and later died. The mesh size of this fence (e.g. 1 x 1 cm (0.25 x 0.25 inch) is smaller than the recommended mesh size (1 inch horizontal, 2 inches vertical). Copyright Kristi Holcomb, Nevada Department of Transportation.

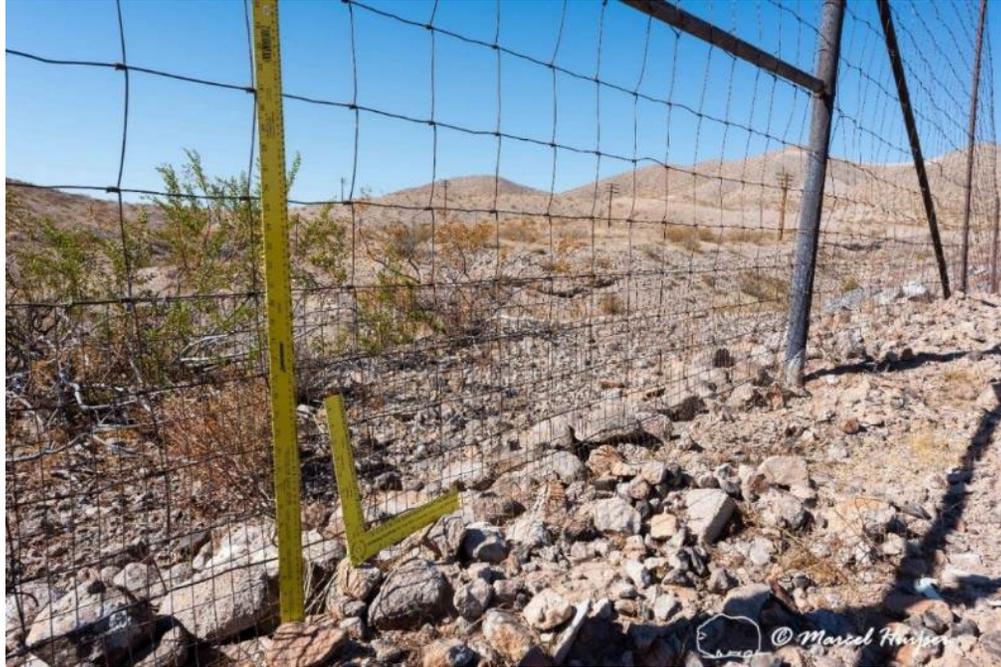
Wildlife fence (8 ft tall (2.4 m)), primarily for desert bighorn sheep (*Ovis canadensis nelsoni*), I-11, near Boulder City, Nevada. Mojave desert tortoises and bighorn sheep are known to co-occur in this area. Therefore, tortoise exclusion fencing was installed at the bottom of the bighorn sheep fencing.

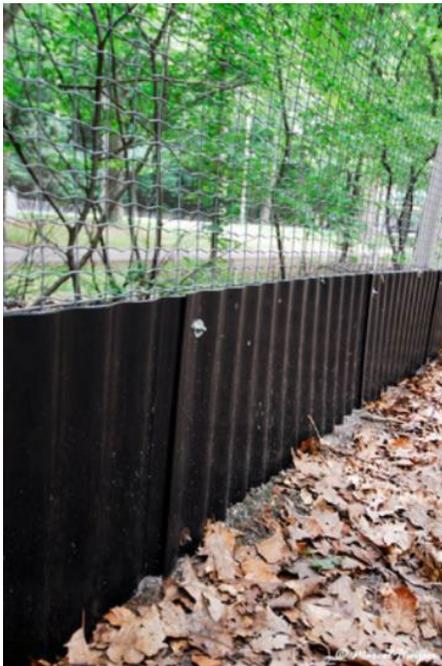
Plastic sheeting for amphibians attached to a Eurasian badger (*Meles meles*) fence, The Netherlands. Depending on the height, the sheeting may be suitable for Mojave desert tortoises. However, in arid ecosystems, erosion and sedimentation processes may be a substantial problem for this design as it is not permeable to water and fine sediments and solid barriers may also be more easily damaged by high winds.

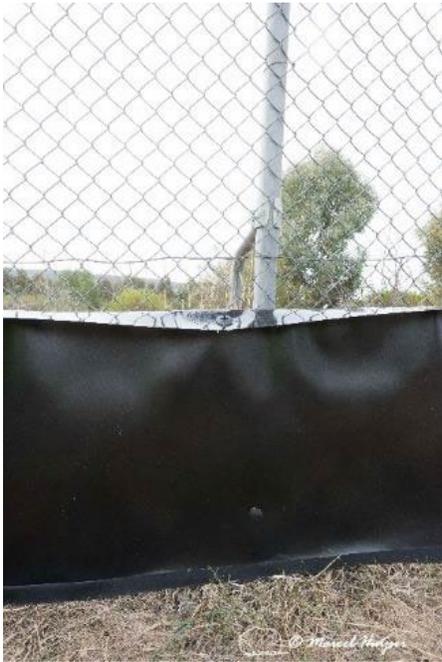
Solid plastic fencing for small animal species attached to a chain-link fence designed for larger wildlife species, M79 motorway, south of Harcourt, Victoria, Australia. However, in arid ecosystems, erosion and sedimentation processes may be a substantial problem for this design as it is not permeable to water and fine sediments and solid barriers may also be more easily damaged by high winds.

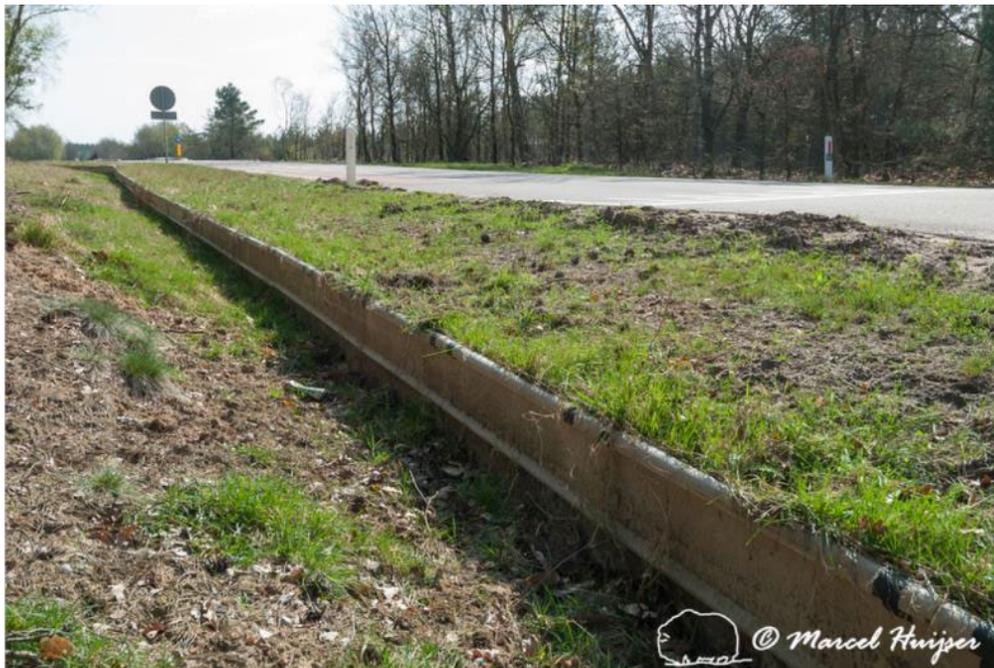
Polymer wall for amphibians integrated into the roadbed, The Netherlands. This type of barrier does not affect landscape aesthetics as experienced from the road. The design also allows for tortoises to exit the road anywhere by tumbling down the barrier. The height may have to be adjusted to prevent large adult desert tortoises from climbing over the barrier while not posing any threat of injury to tortoises that may fall over the barrier.

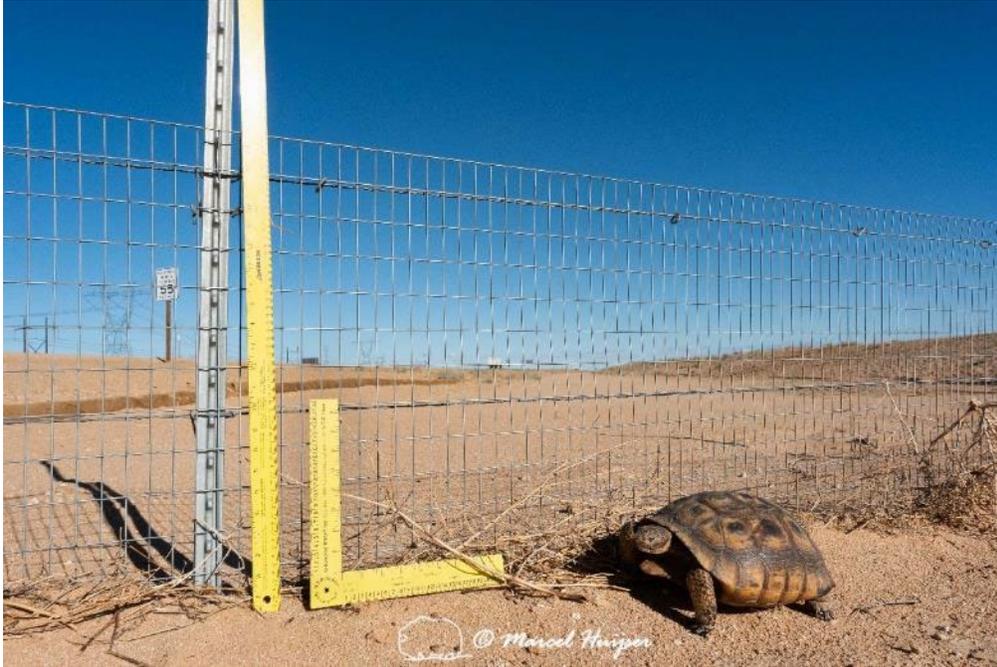
Mojave desert tortoise fence (height above ground 24 inches, presumably buried 12 inches below ground level, mesh size 1 inch wide, 2 inches tall), Hwy 58 near Kramer Junction, California. The fence material is attached to smooth wires at 10 and 22 inches above the ground.

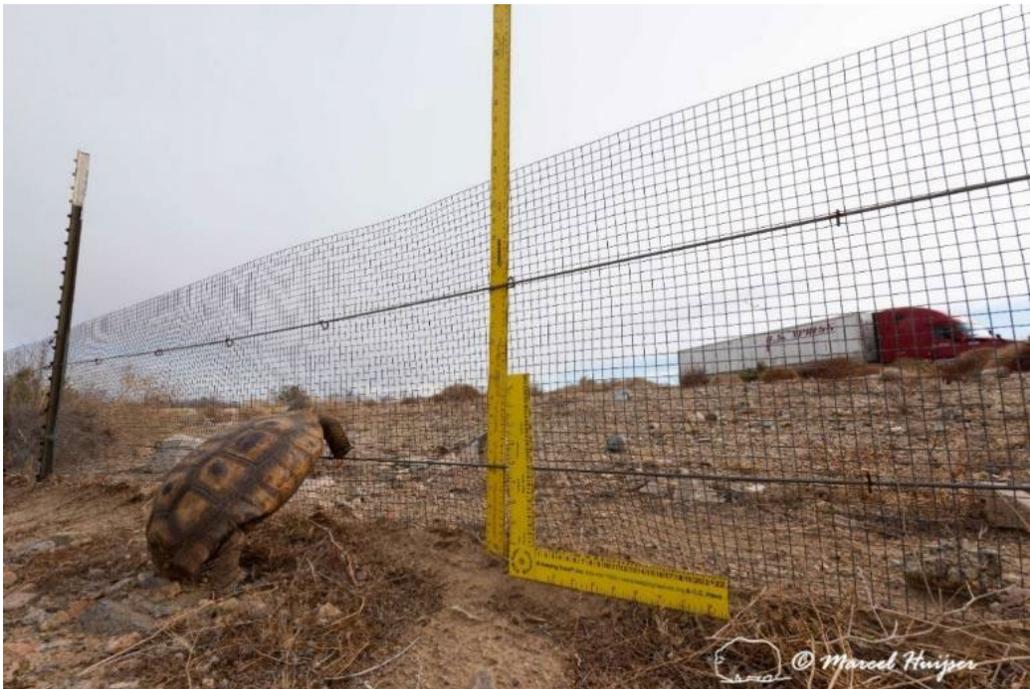
Mojave desert tortoise fence (about 21.5 inches tall, mesh size about 1x1 cm), I-15 near Barstow, California. The small mesh size may pose a greater risk to small animal species (lizards, snakes) getting stuck and dying. Small mesh sizes are

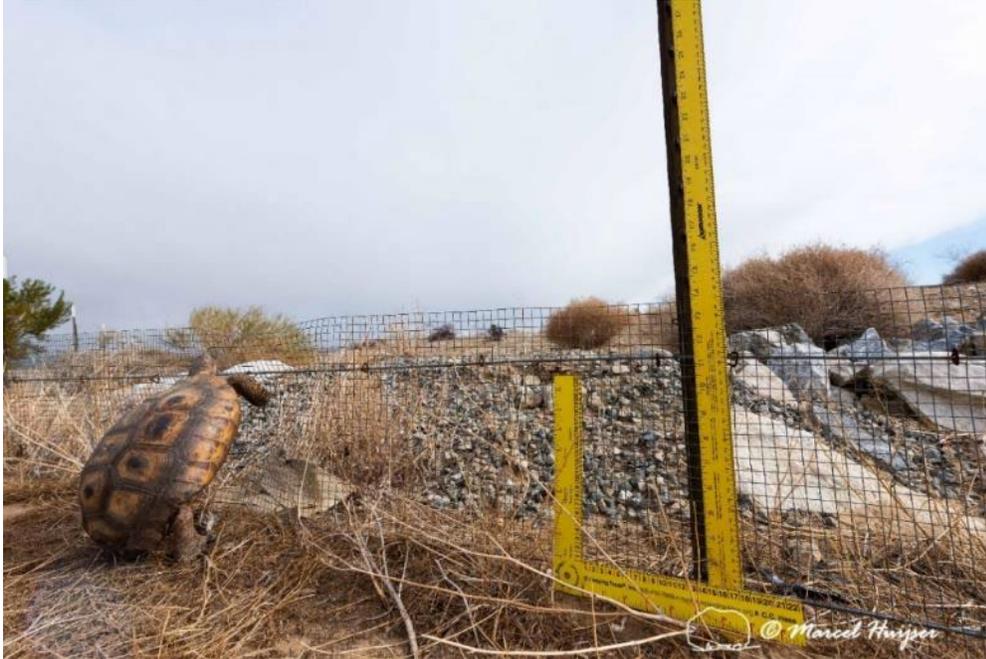
Mojave desert tortoise fence (about 14 inches tall, mesh size about 1x1 cm), I-15 near Barstow, California. The small mesh size may pose a greater risk to small animal species (lizards, snakes) getting stuck and dying. Small mesh sizes are also more likely to catch sediment. Note that this fence is too low and there is no smooth wire at the very top of the fence, making the fence less rigid.

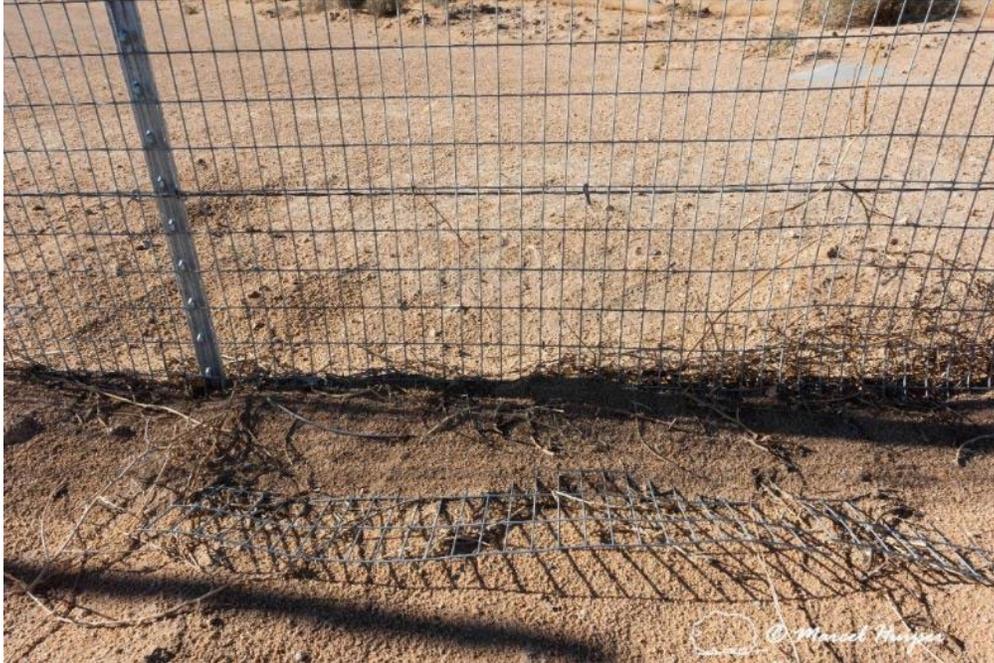
Mojave desert tortoise exclusion fence, Hwy 58 near Kramer Junction, California. Here the fence is angled towards the safe side of the fence (not the roadside), presumably because of rocky soil. Also note that the section of the fence that lies on the ground should be buried up with to 4 inches of rocks and soil on top, leaving a barrier height of 22-24 inches above the ground level.

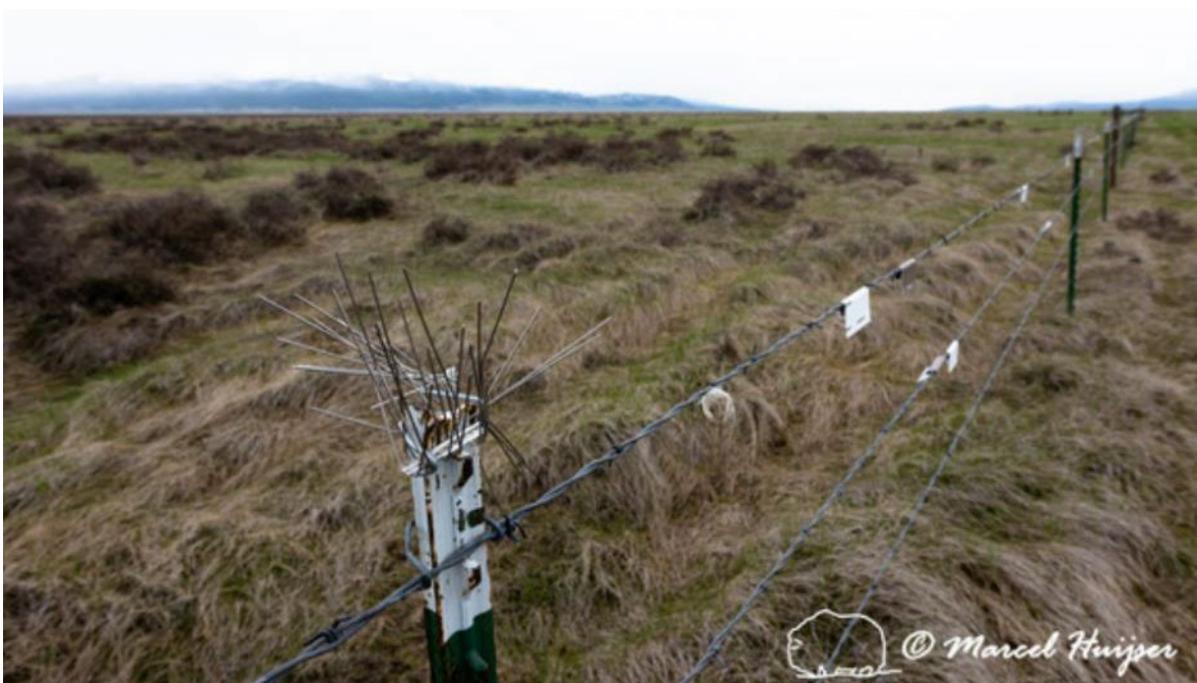
Fence markers and bird spikes on t-posts, Montana. The markers are designed to reduce the likelihood that sage grouse (*Centrocercus urophasianus*) fly into the livestock fence. The bird spikes are designed to reduce the likelihood that corvids or raptors will use the fence posts to perch and prey on sage grouse, especially the chicks. Installation of bird spikes on fence posts attached to fences in desert tortoise habitat may help reduce predation on tortoises by birds within adjacent habitat.

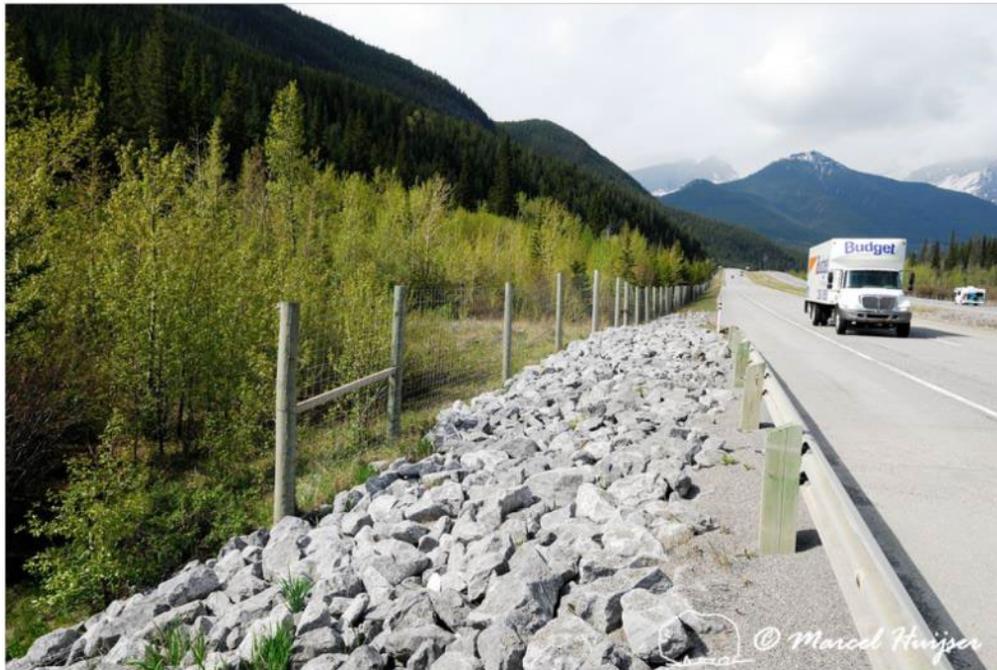
Boulder field at a fence-end, shielded through a guard rail, Alberta, Canada.

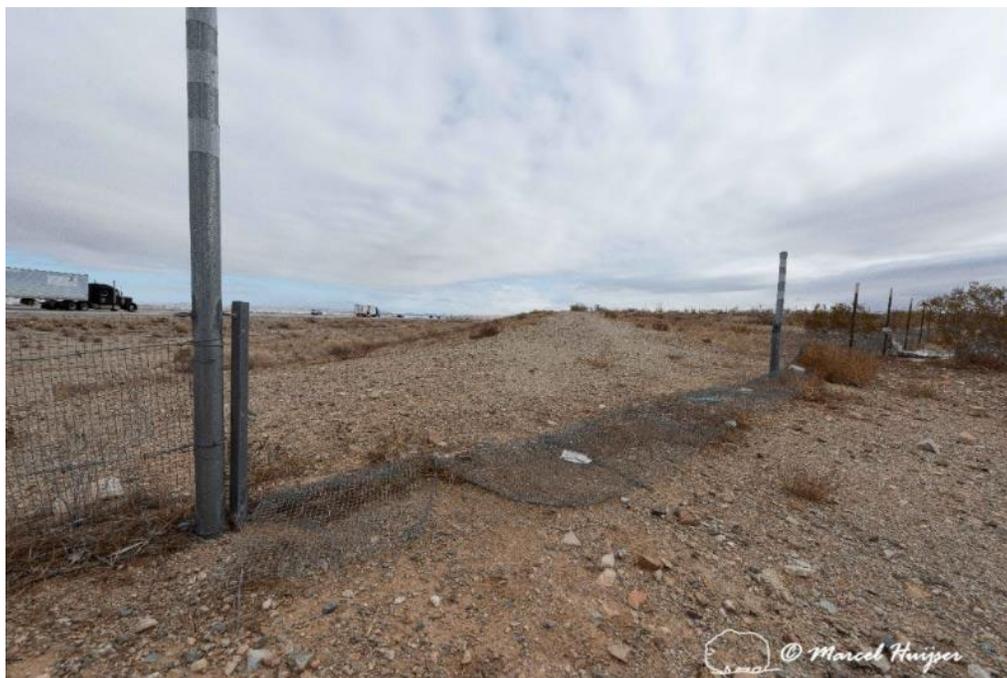
Flattened and destroyed gate at a vehicle access point associated with a Mojave desert tortoise fence, I-15 near Barstow, California. Here the fence has, or had, a gate for a dirt road, but the fence was flattened by vehicles. This suggests that gates that require people to get out of the vehicles to open

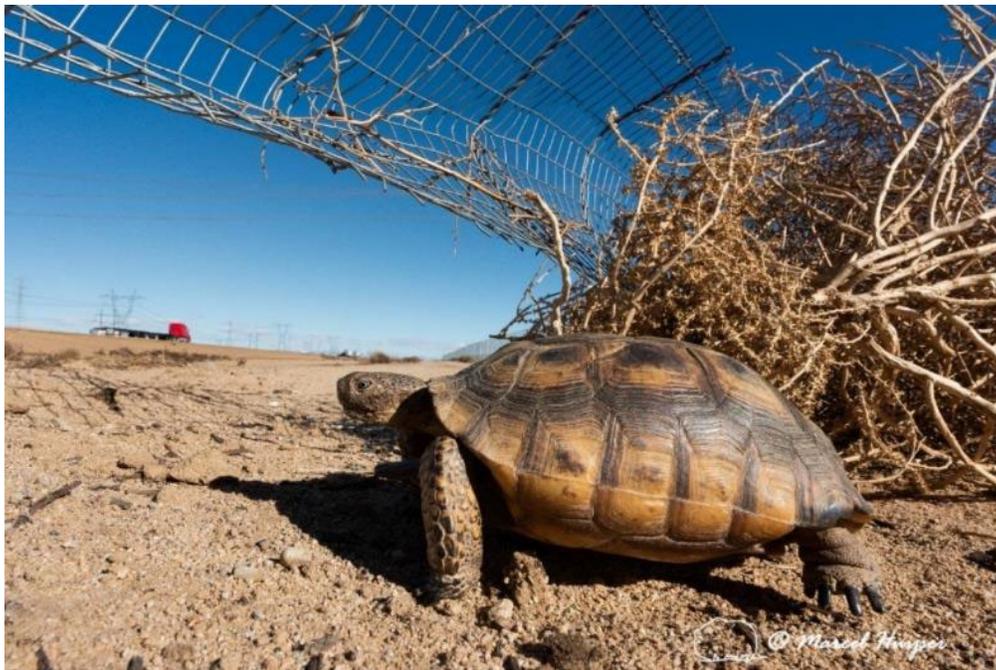
Gap under a gate associated with Mojave desert tortoise exclusion fencing, Hwy 58 near Kramer Junction, California. The gate does not have a buried component, and it had enough flex to result in permanent openings, partially as a result of tumbleweeds being blown against the fence.

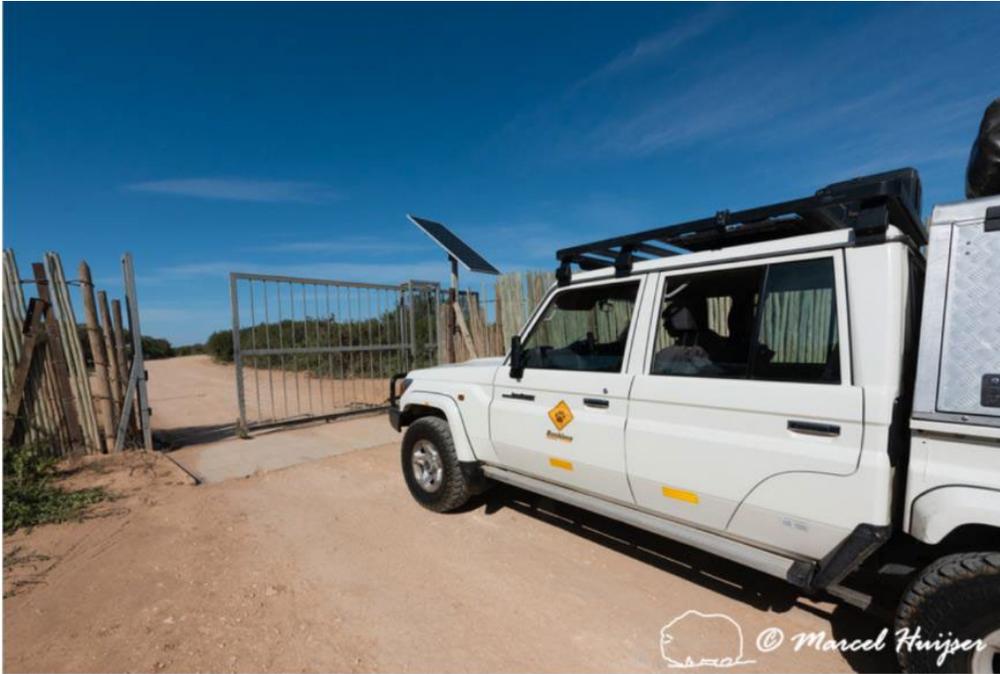
Automatic gate with a push-button to open (to the right of vehicle because of right hand driving), Addo Elephant National Park, Eastern Cape, South Africa

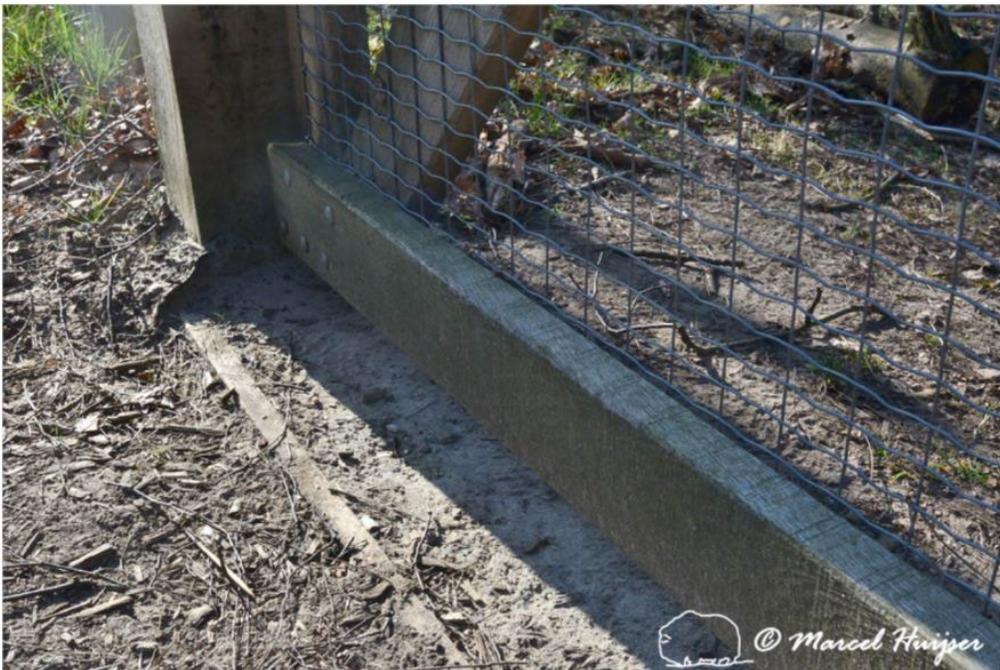
Snug fit of a gate at a wildlife fence, south of Otterlo, The Netherlands. The snug fit discourages animals from crawling under the gate.

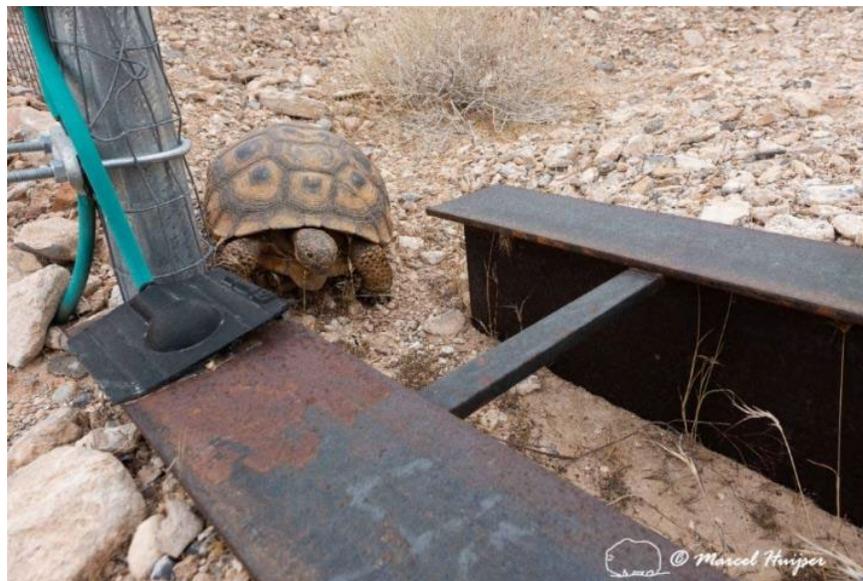
Tortoise guard consisting of two I-beams, welded together with connectors, for Mojave desert tortoise, US Hwy 93 (MP 58 NB) near Overton, Nevada. The tortoise approaches from the safe side of the fence (not the roadside). Note, that larger adult tortoises may not fit within, and may be able to gain access to the roadside across this structure. **This design is no longer recommended** because Mojave desert tortoises may still cross, and the structure does not stand up to heavy vehicles and high temperatures, and they are susceptible to erosion (Pers. com. Kerry Holcomb, USFWS; Kristina Drake, USFWS; Glen Knowles, USFWS).

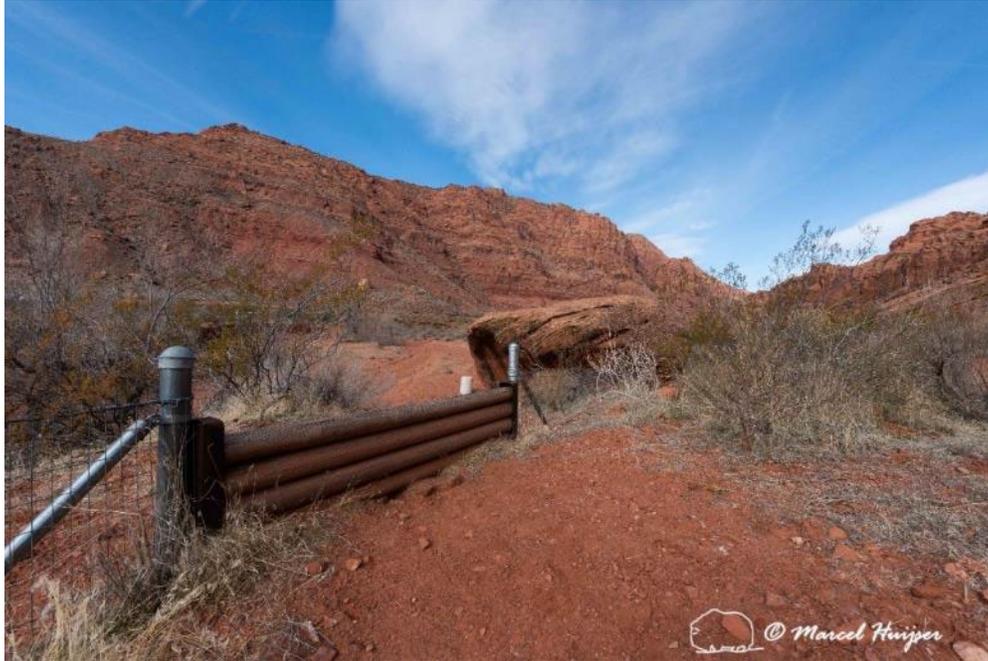
Barrier on a hiking trail, designed to keep Mojave desert tortoises out of an area, St. George, Utah. Hikers may step over this barrier to continue on the trail, while tortoises cannot gain access to the road on the other side.

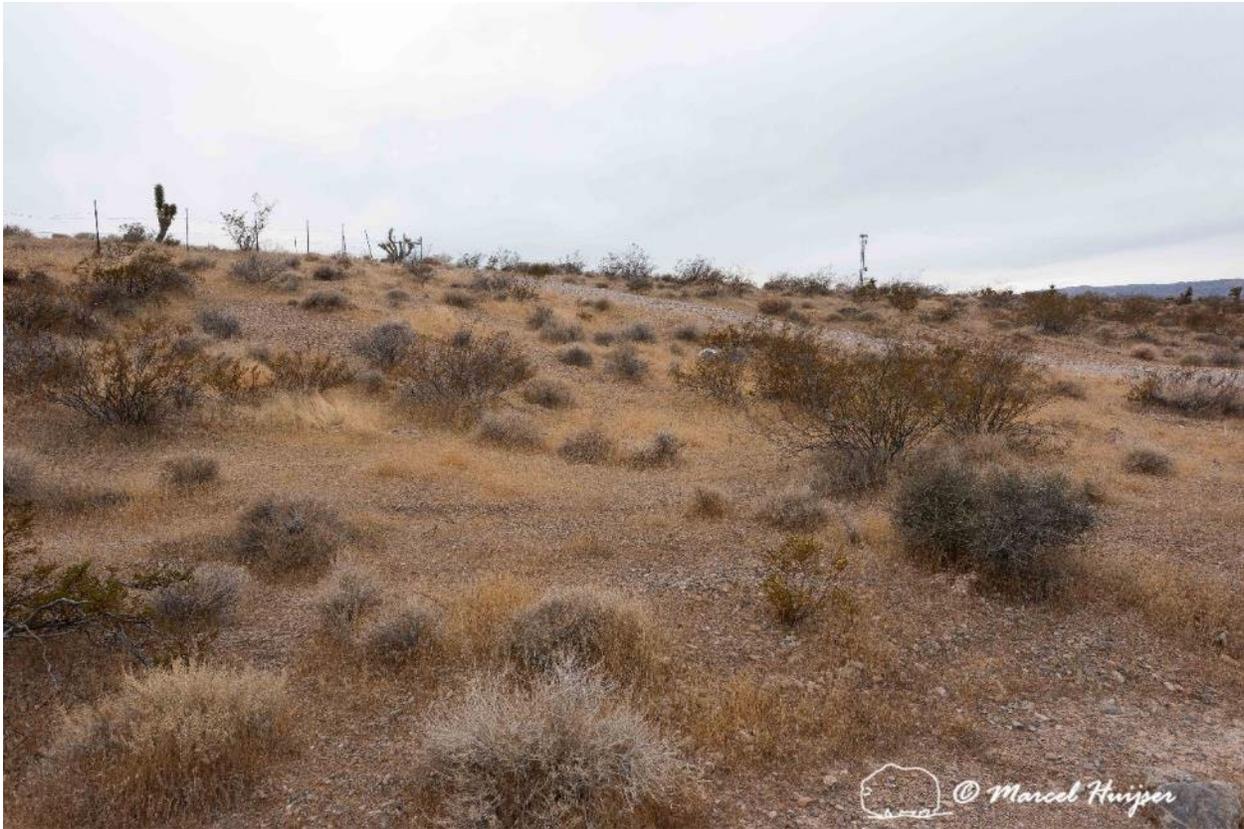
Mojave desert tortoise exclusion fence on the left, located on high ground adjacent to a desert wash leading to a culvert under US Hwy 93 (MP 58) near Overton, Nevada.

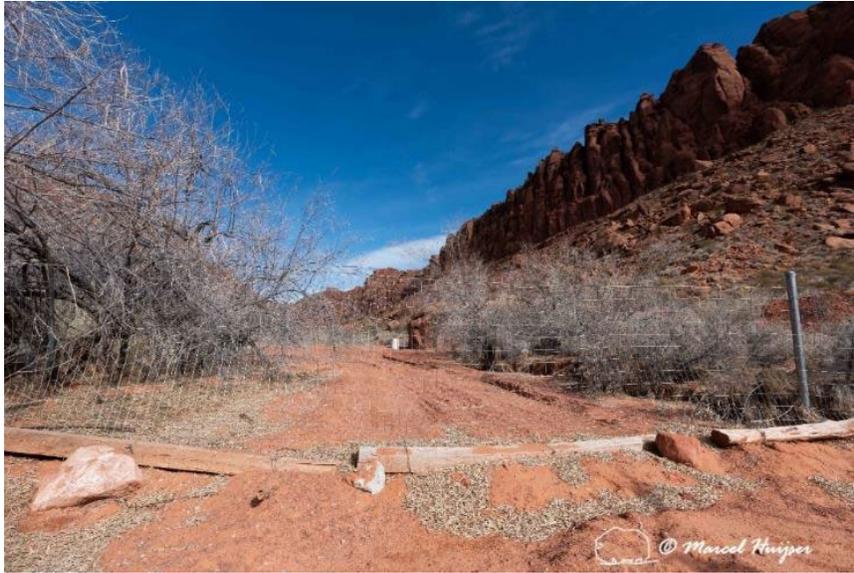
Mojave desert tortoise exclusion fencing across a desert wash, St. George, Utah. Here the fence crosses a desert wash. The cedar logs will float and lift up the fence during a flooding event. This minimizes damage to the fence because of flooding and debris.

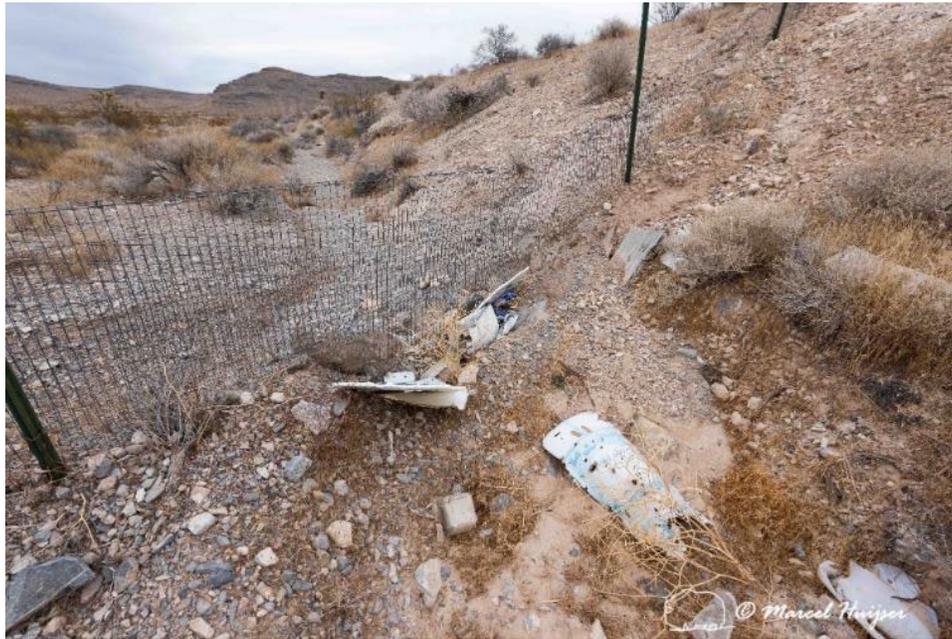
Mojave desert tortoise exclusion fencing across a desert wash with sedimentation at the fence, US Hwy 93 (MP 58 NB) near Overton, Nevada. The sedimentation reduces the effective height of the fence, and it may eventually threaten the integrity of the fence. Also note that the fence material has been cut in multiple overlapping segments to allow for the change in angle because of the change in slope (see next image for details).

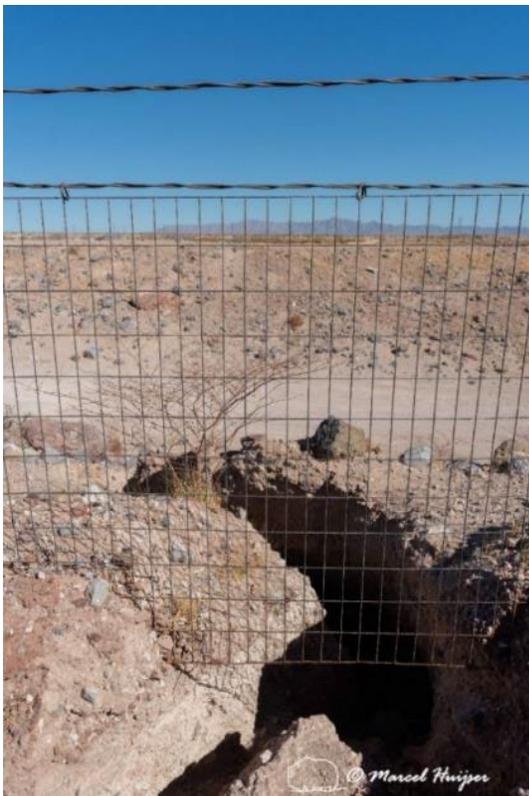
Mojave desert tortoise fencing with soil erosion, I-11, near Boulder City, Nevada. Note that the animals may now move in the erosion gully under the fence. Also note that the fence appears to have only been dug 6 inches into the ground rather than the recommended minimum 12 inches.

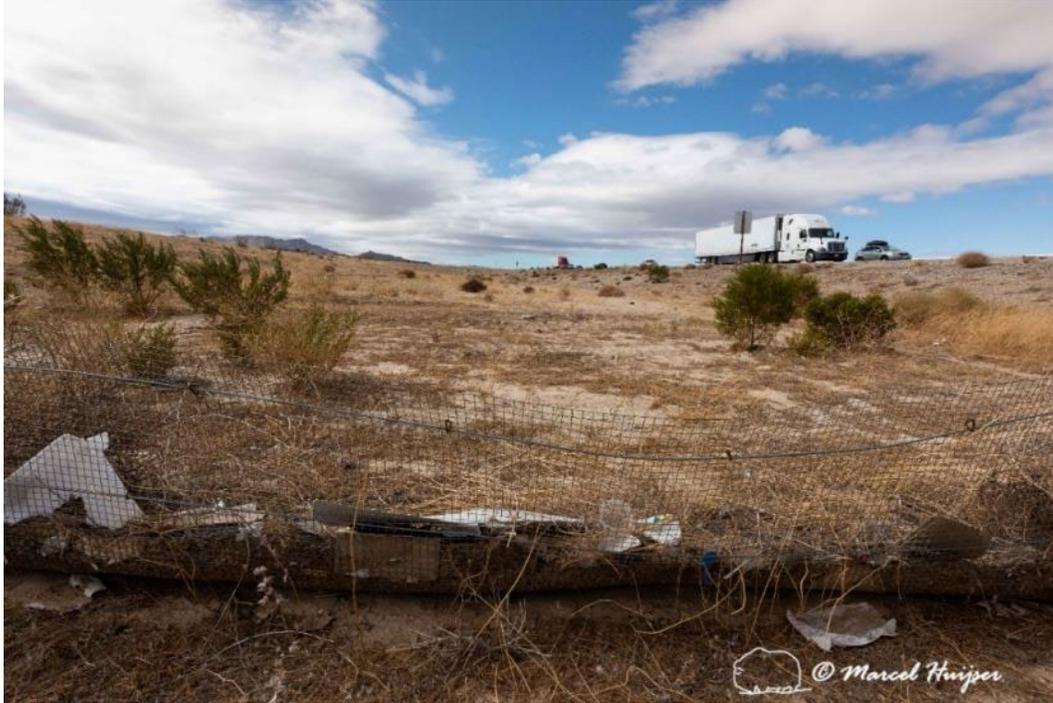
Mojave desert tortoise fencing installed across a low lying area, along I-15 near Barstow, California. Here debris (rocks, sand, garbage) has built up against the fence because water runs down the slope against the fence.

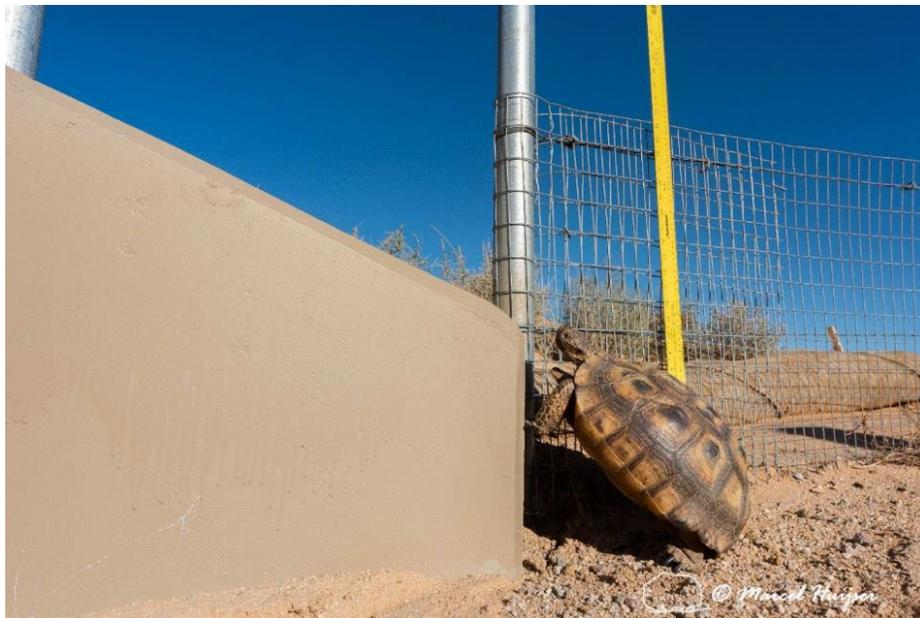
Mojave desert tortoise fencing connected to the wingwall of a culvert, Hwy 58 near Kramer Junction, California. While the connection between the fence and wingwall is tight and should not allow Mojave desert tortoises to access the fenced road corridor, the effective height at the connection is only about 11 inches instead of the recommended 22-24 inches. The fence material should have been continued until the point where the wingwall has a height of 22-24 inches.

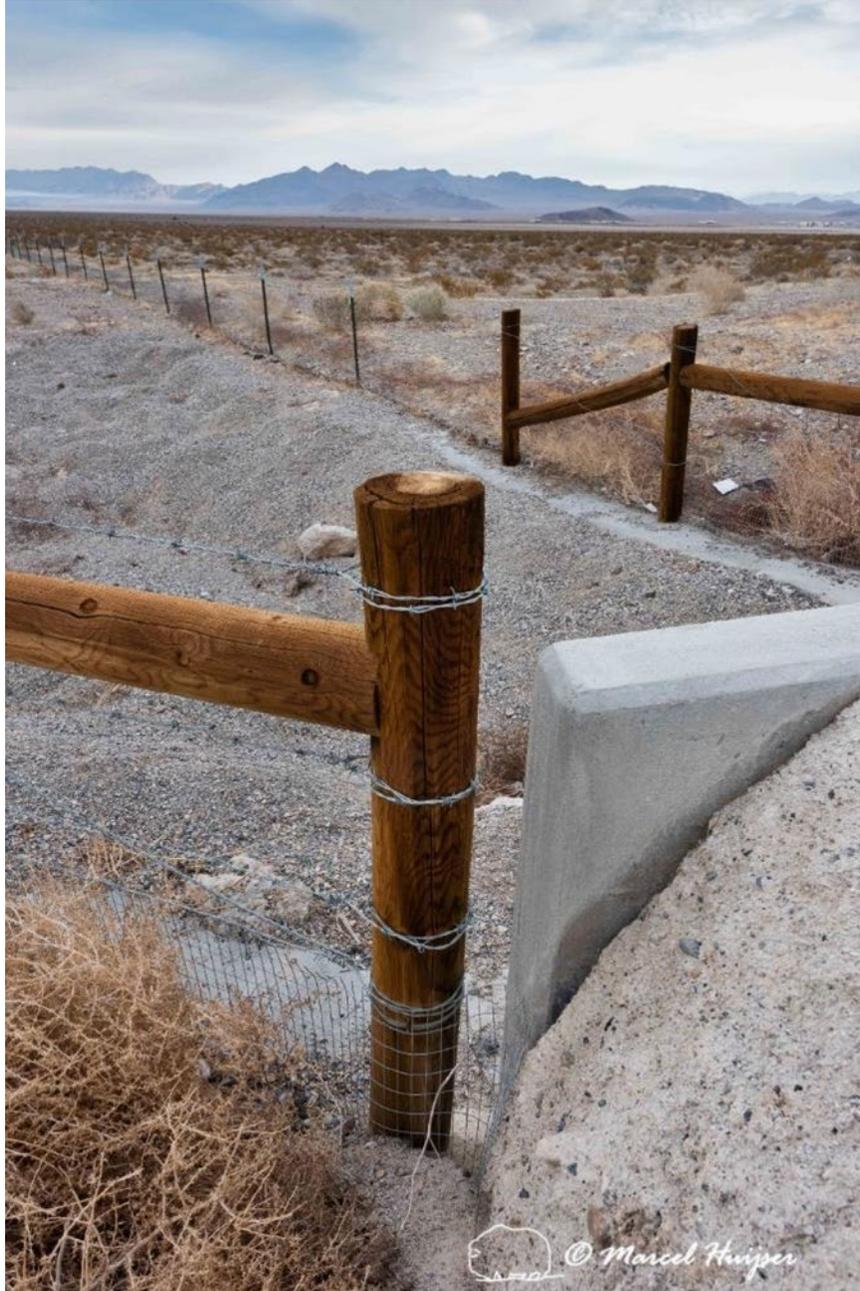
Mojave desert tortoise fencing connected to a culvert, US Hwy 95 (MP 121.6 NB) near Indian Springs, Nevada. Note concrete access paths for Mojave desert tortoises constructed along the fence.

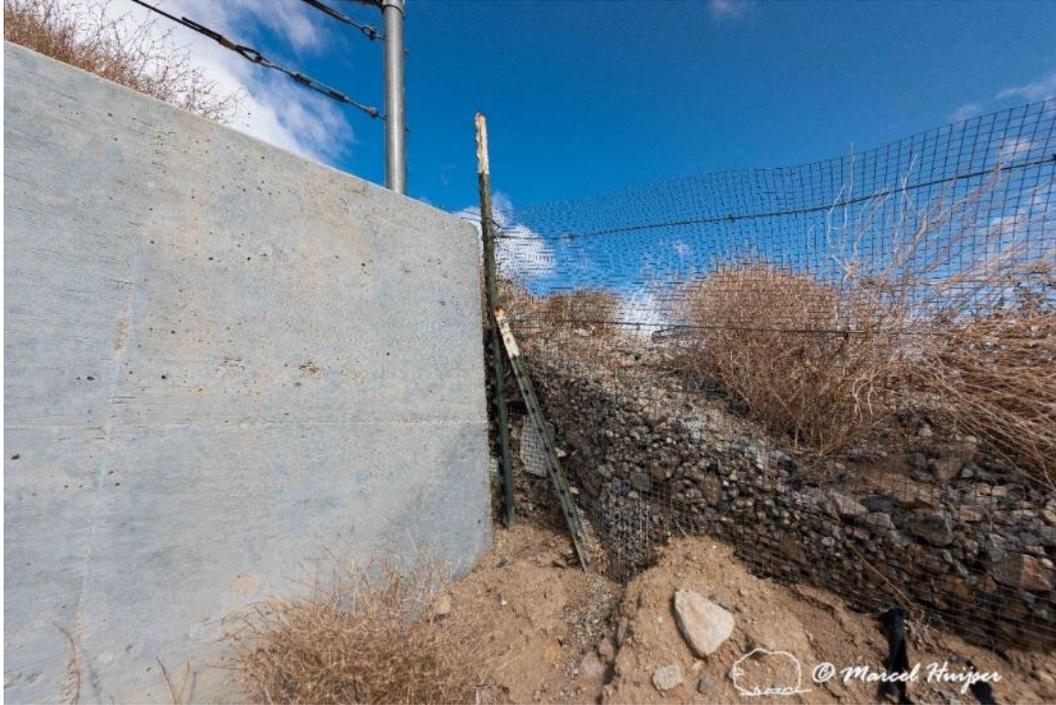
Mojave desert tortoise fencing connected to a culvert, I-15 near Barstow, California. Here debris (rocks, sand) has built up against the fence, threatening its integrity.

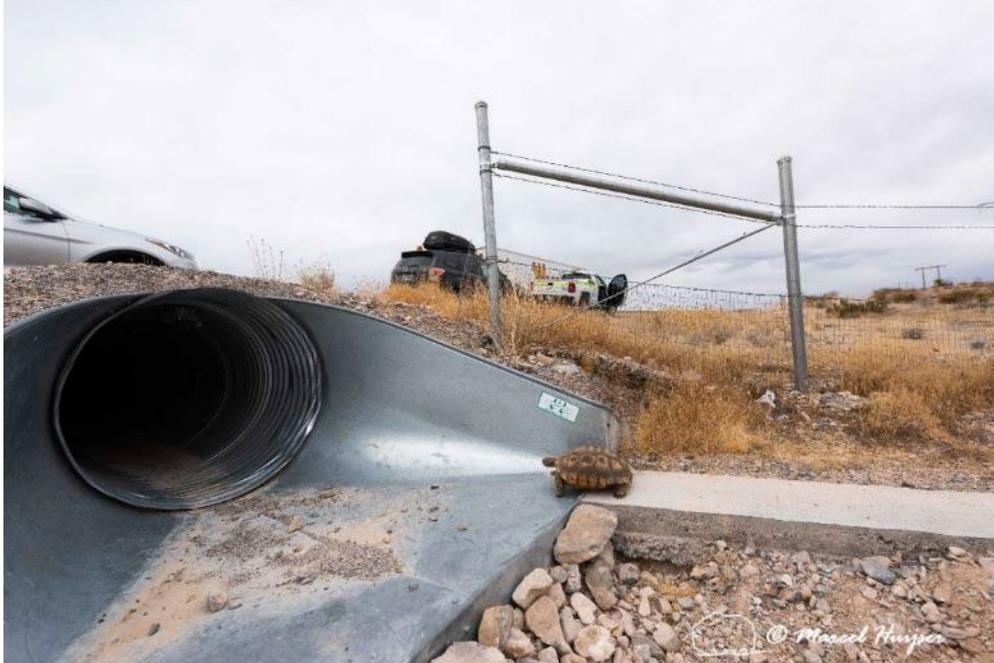
Mojave desert tortoise fencing connected to a culvert, US Hwy 93 (MP 58 NB) near Overton, Nevada. The fencing would be a more effective barrier if it was continued above the culvert without any gap in the fence.

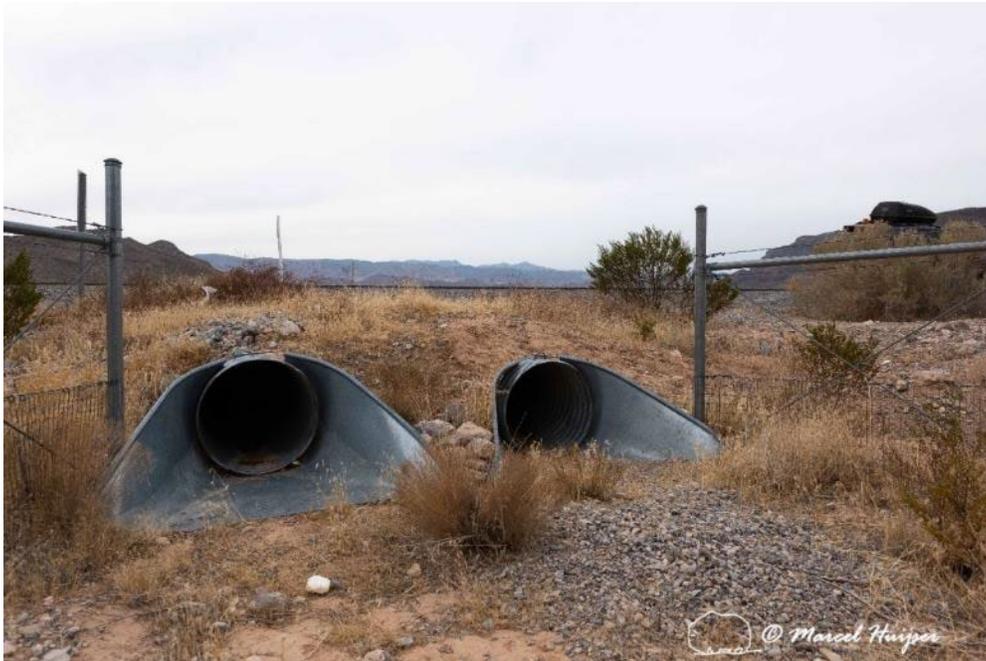
Mojave desert tortoise fencing connected to twin culverts, US Hwy 93 (MP 69.5 NB) near Overton, Nevada. The fencing would be a more effective barrier if it was continued above the culvert without any gap in the fence.

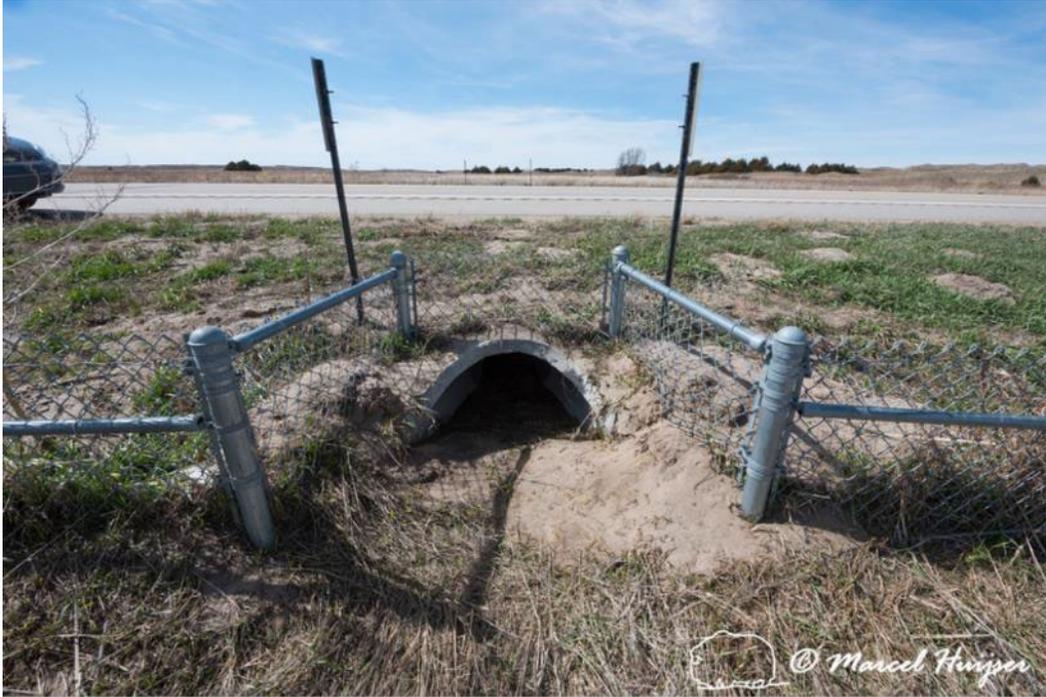
Turtle fence and a dry culvert used by turtles, Valentine National Wildlife Refuge, Ballard's South, Valentine, Nebraska, USA. This culvert is 30 inches wide, 22 inches tall. Note that this turtle fence has no gap and continues behind and on top of the culvert.

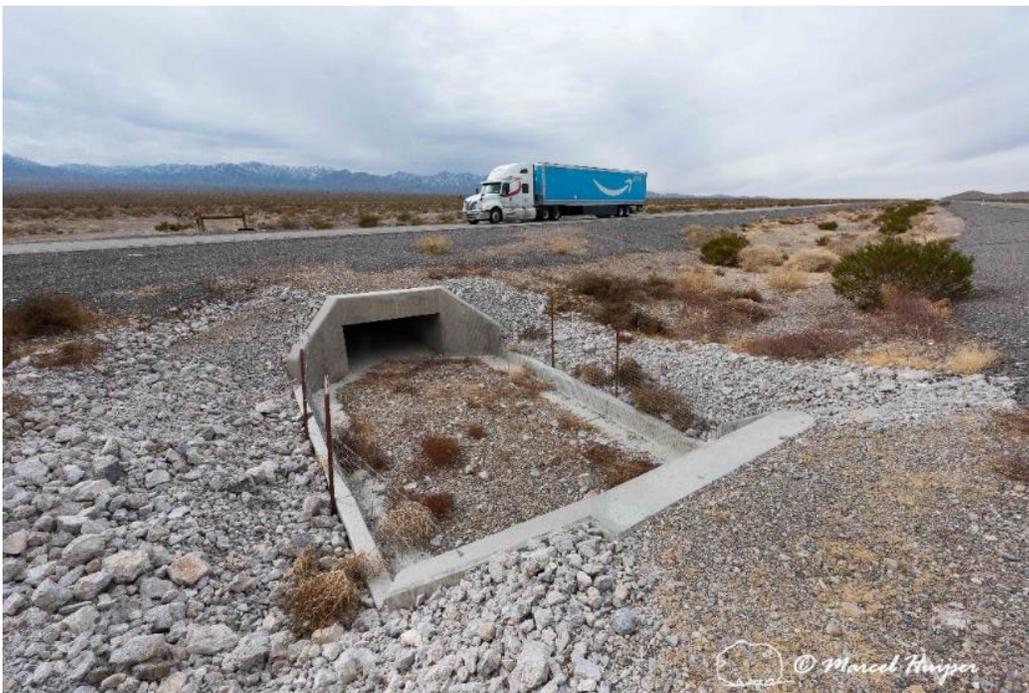
Open medians with separate crossing structures for the two travel directions should have Mojave desert tortoise fencing installed to prevent tortoises from accessing the fenced road corridor in the median.

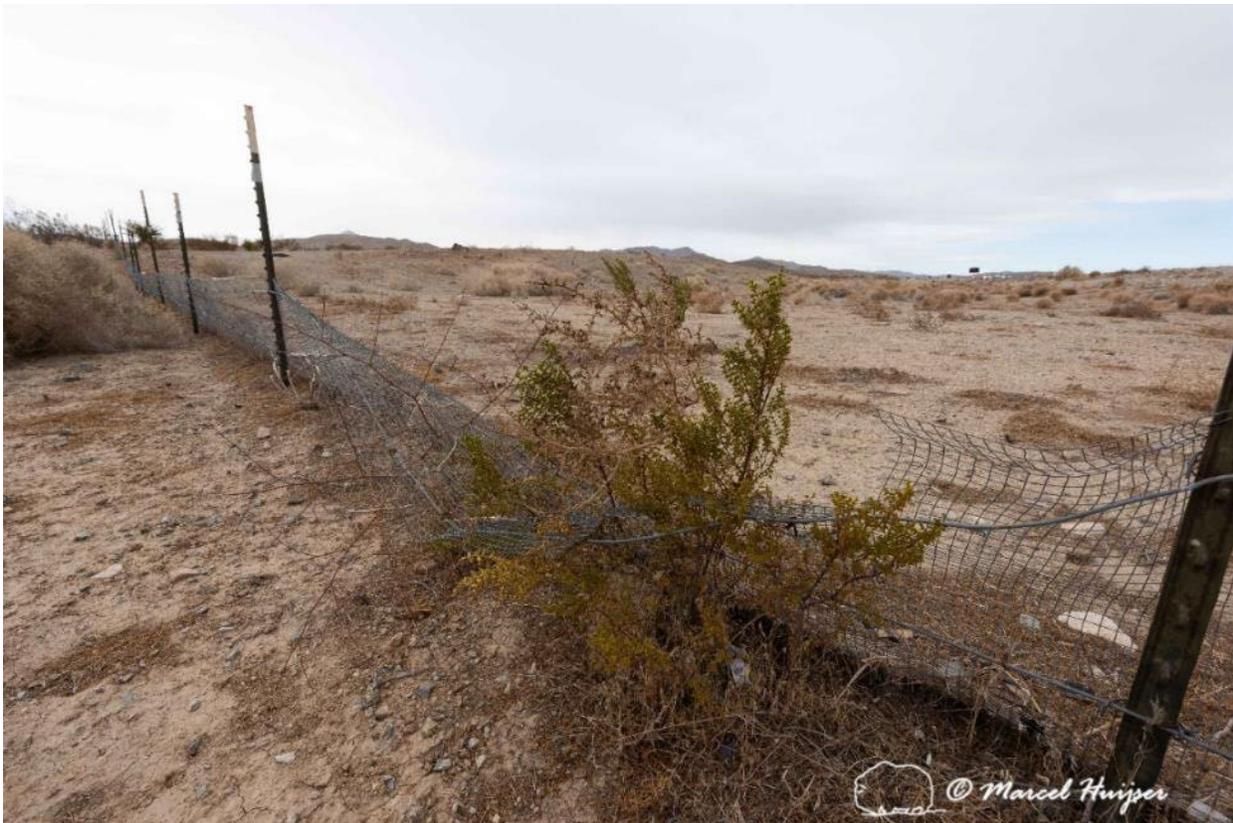
Mojave desert tortoise fencing, I-15 near Barstow, California. The fence is in disrepair and a shrub has grown through the fence, reducing its effective height.

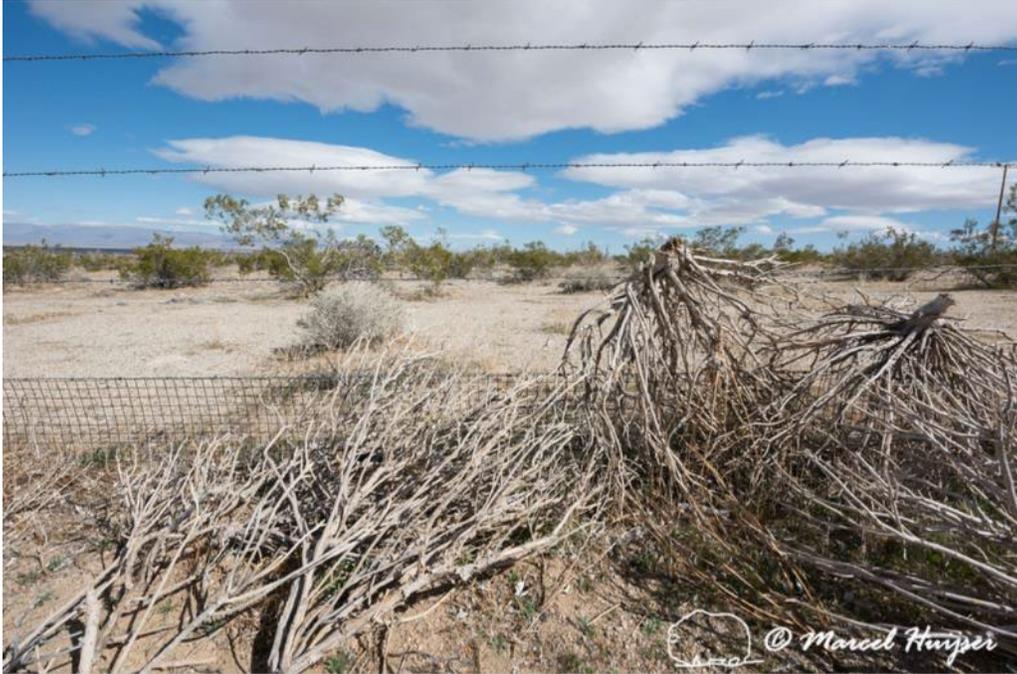
Dead vegetation has blown against the Mojave desert tortoise fence, reducing the barrier effect of the fence to keep tortoise from accessing the highway, Aerospace Hwy, Hwy 14 near Inyokern, California. Note that the height of the fence, as installed, is insufficient to begin with.
