Technical Guidance: Mojave Desert Tortoise Conservation and Recovery Measures Along Roads

Elizabeth Fairbank¹, Marcel Huijser², and Florence Deffner³

Mojave Desert Tortoise Transportation Ecology Task Force

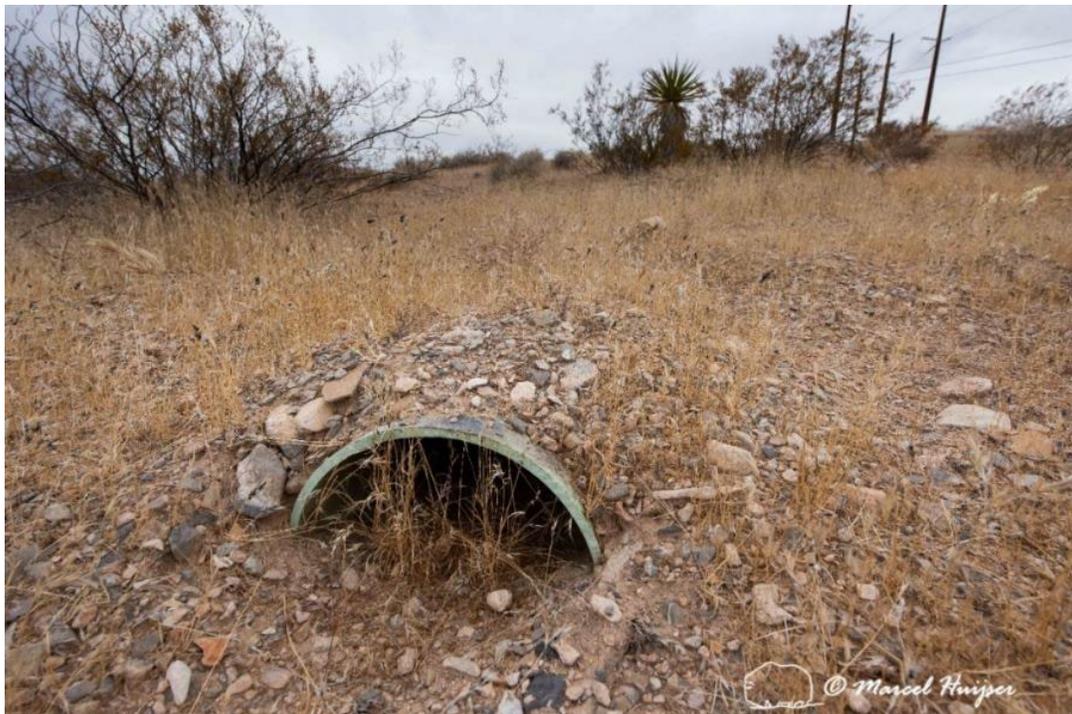
Artificial shade structure for Mojave desert tortoises, along US Hwy 93 (MP 58 NB) near Overton, Nevada.

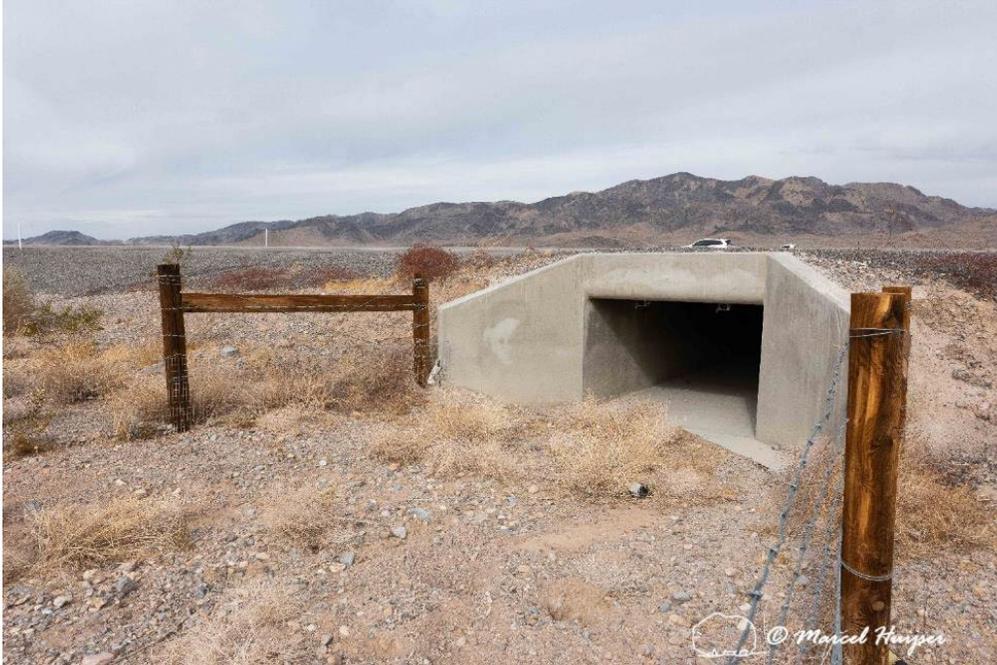
A multifunctional concrete culvert with natural substrate leading up to it, primarily designed for hydrology, but adapted for use by Mojave desert tortoises, US Hwy 95 (MP 125 SB) near Indian Springs, Nevada.

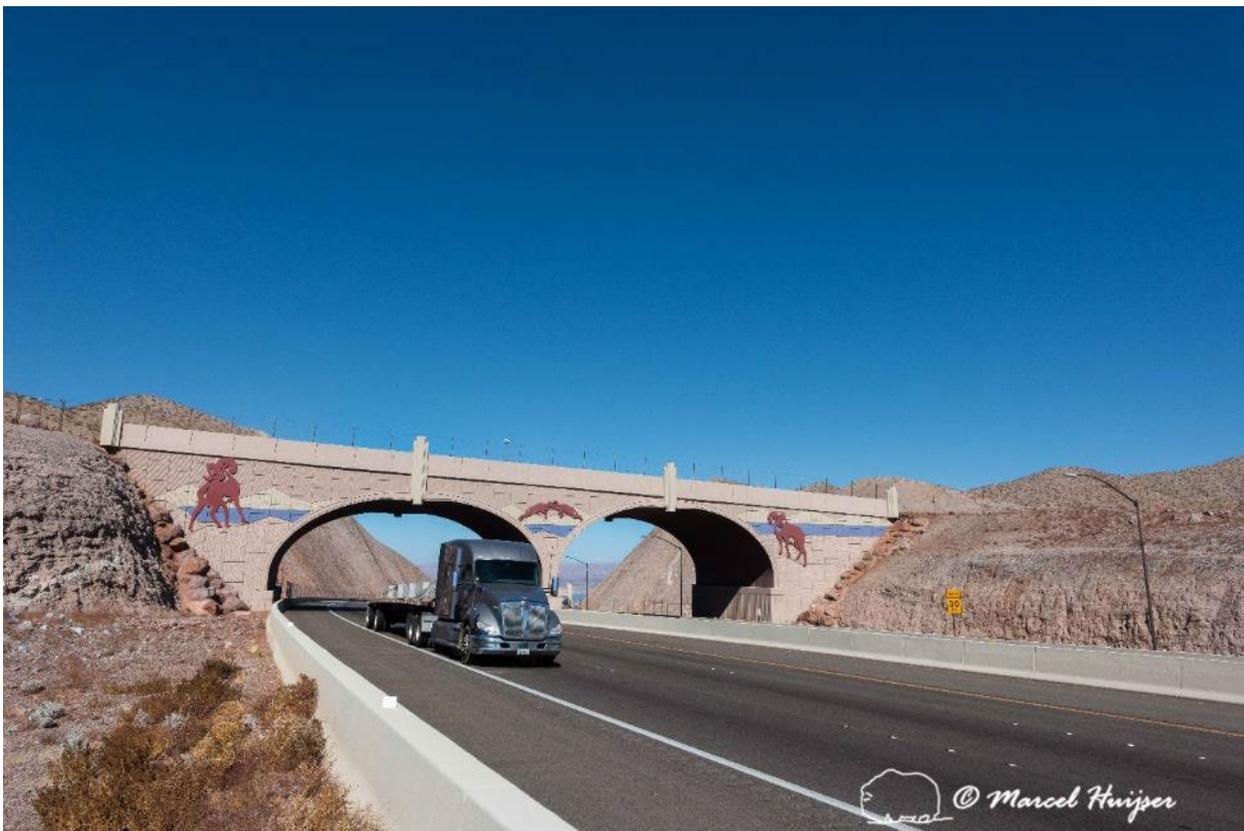
Wildlife overpass primarily designed for desert bighorn sheep, I-11, near Boulder City, Nevada.

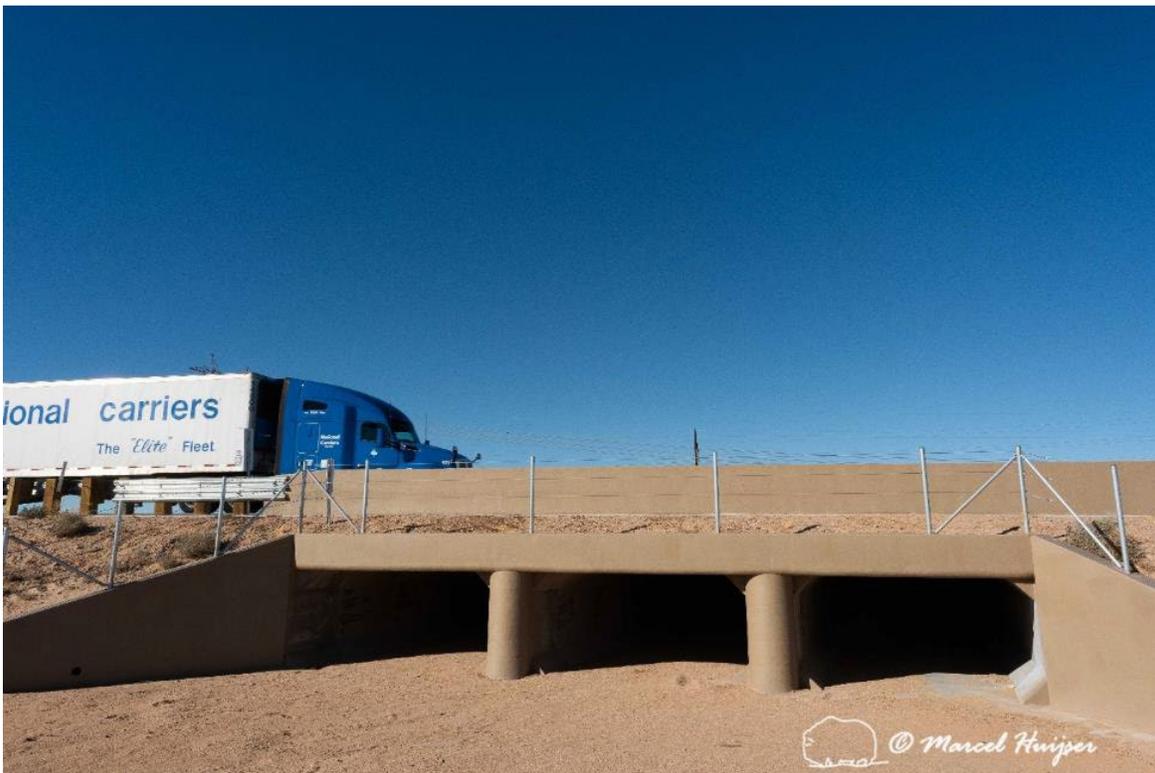
Culverts, primarily designed for hydrology, but also for Mojave desert tortoises, Hwy 58 near Kramer Junction, California. There is no erosion or sedimentation at this approach that would constitute a barrier to tortoises. However, having one open structure, not separated by dividing walls, would likely be better for wildlife use in general.

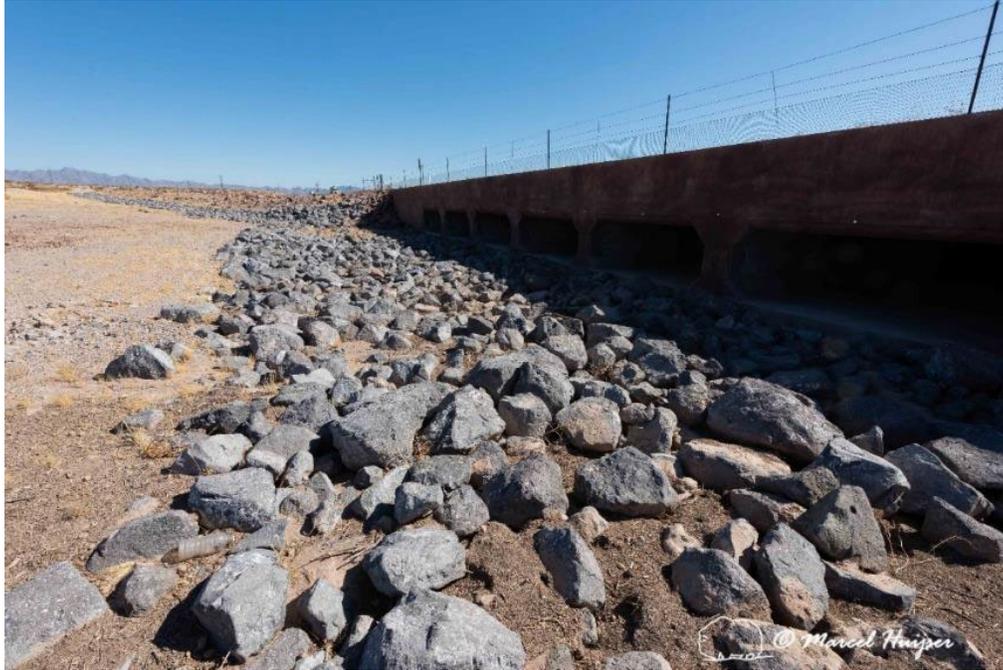
Riprap in front of culverts to reduce erosion, I-11, near Boulder City, Nevada. While beneficial to combatting erosion and sedimentation issues, the size and placement of the riprap most likely results in a substantial barrier to Mojave desert tortoises.

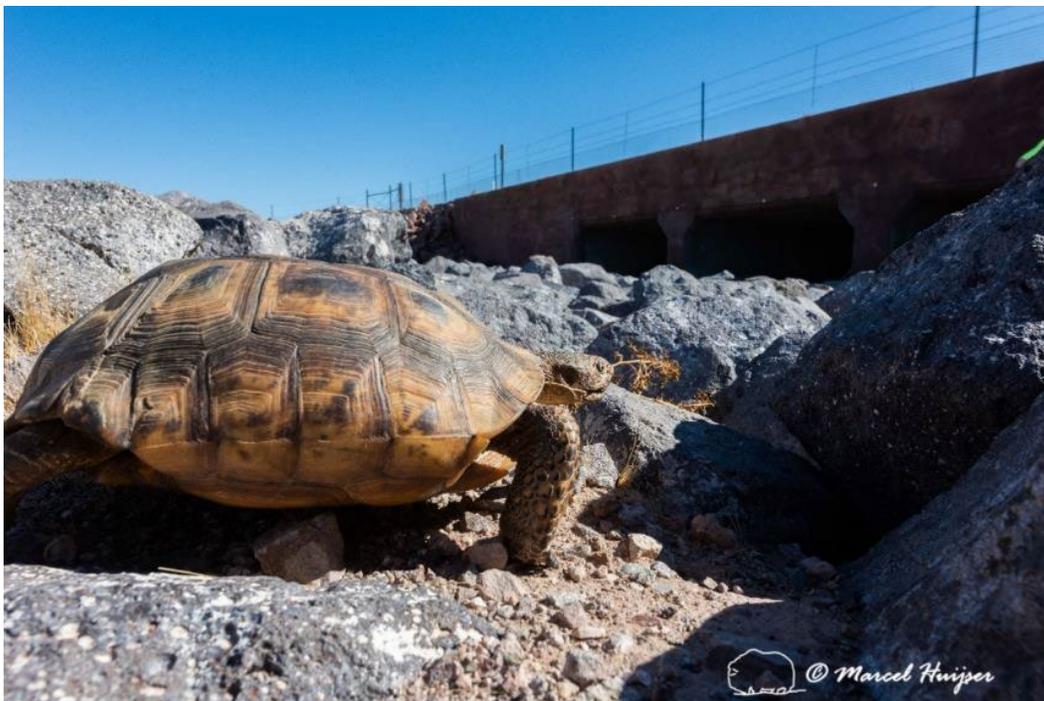
This is what the riprap field looks like from the perspective of a desert, I-11, near Boulder City, Nevada. The riprap is likely an absolute or near absolute barrier to tortoises.

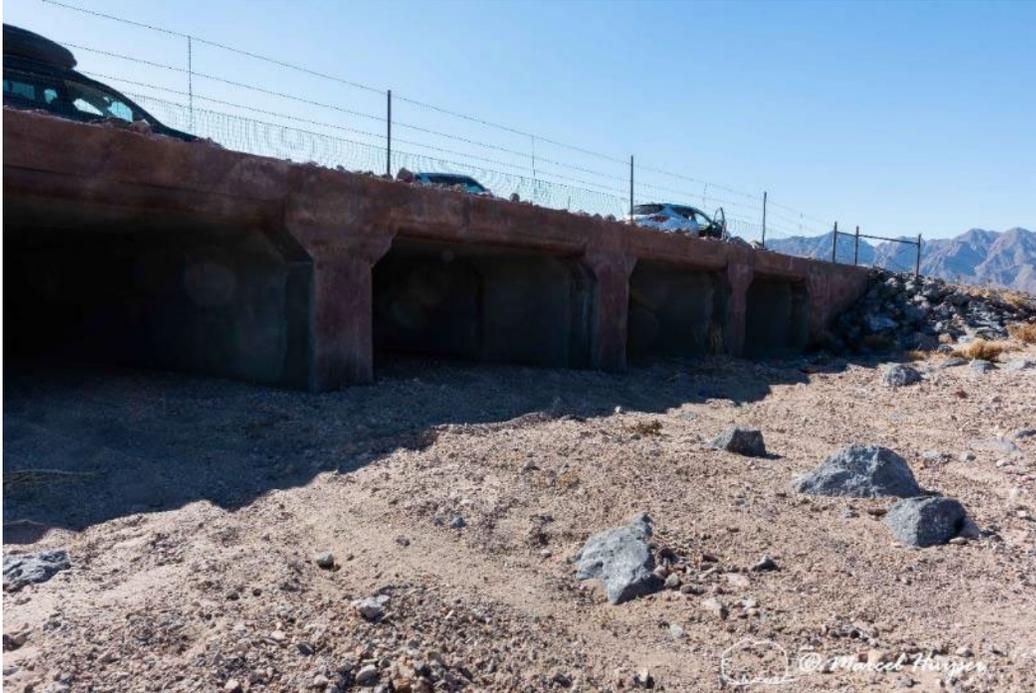
Riprap filled in with finer rocks and sand, in front of culverts to reduce erosion, I-11, near Boulder City, Nevada. This does not appear to be a barrier to Mojave desert tortoises.

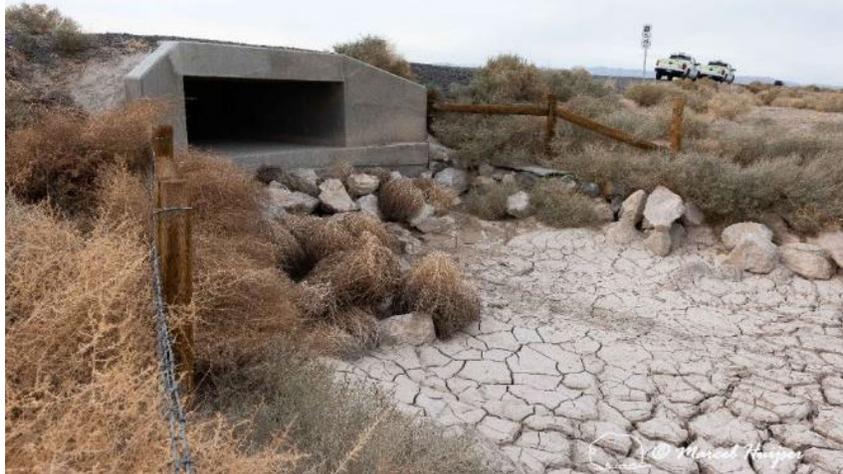
Mojave desert tortoise fence connected to a concrete box culvert with a substantial drop-off, large riprap, accumulated tumbleweed, and eroded pathways likely result in a barrier for Mojave desert tortoises, US Hwy 95 (MP 125 NB) near Indian Springs, Nevada. Drop-offs greater than 4 inches may not be accessible for most tortoises (Pers. com. Kerry Holcomb US Fish and Wildlife Service). The cracked substrate within the deep plunge pool is an indication that standing water accumulates after storm events, which may attract tortoises that are then at a risk of drowning. The tumbleweed accumulation may block or discourage use by Mojave desert tortoises and should be addressed through regular maintenance (i.e. removal of the tumbleweeds). However, access to this culvert and plunge pool was eventually blocked because it was not possible to address the safety issues for tortoises with the existing hydraulic characteristics.

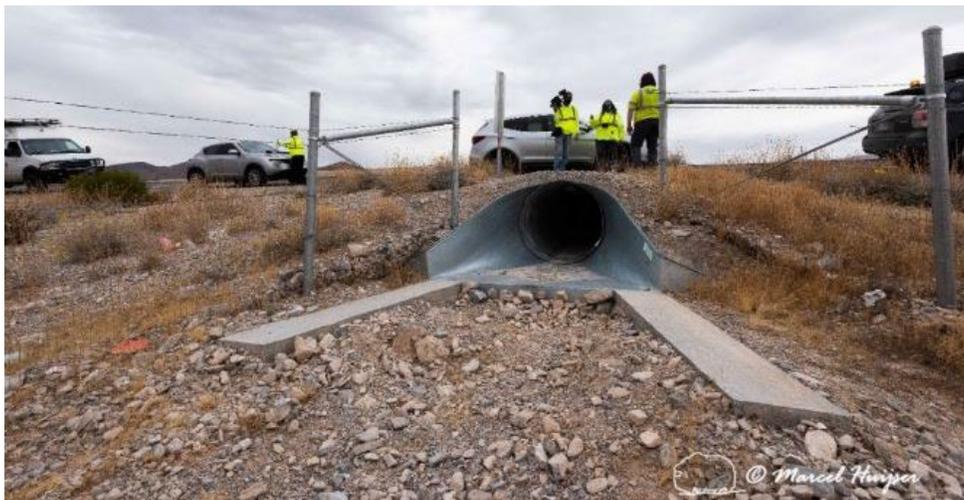
Mojave desert tortoise fence connected to a corrugated metal pipe (culvert) (CMP) with concrete pathways on both sides for Mojave desert tortoises, US Hwy 93 (MP 58 NB) near Overton, Nevada. Note that erosion resulted in a drop-off at the outflow of the culvert and this is likely a barrier to juvenile tortoises. While this culvert is passable for Mojave desert tortoises, improvements can be made by reducing the height of the drop-off.

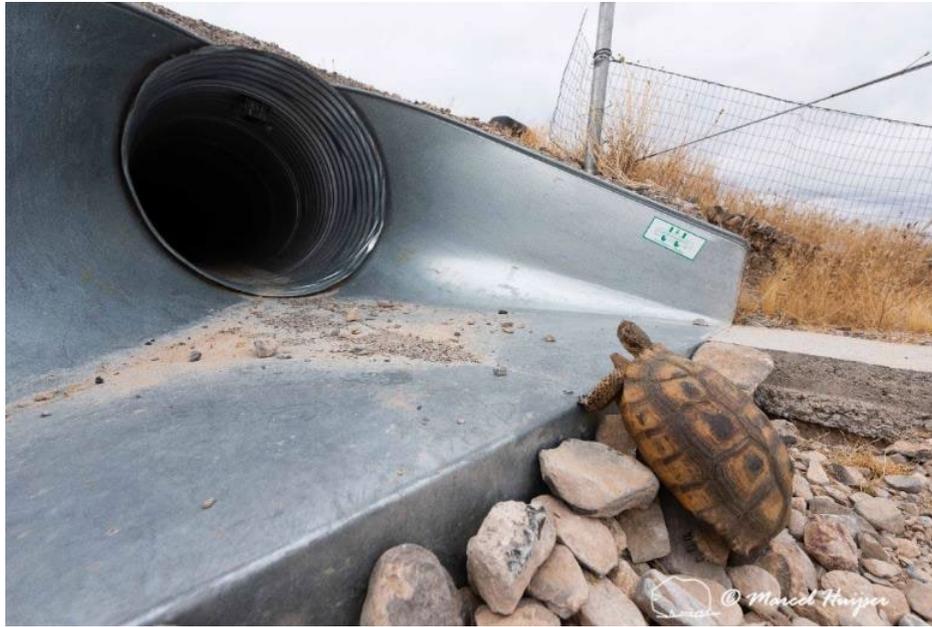
Close-up with adult tortoise model at a corrugated metal culvert (Corrugated Metal Pipe (CMP), US Hwy 93 (MP 58 NB) near Overton, Nevada. Note that the height of the drop-off at the outflow of the culvert is likely a barrier for smaller size tortoises. While adult tortoises have been observed to pass through this culvert, regular monitoring and maintenance to address the effects of erosion can help keep a culvert passable by a both adult and juvenile tortoises.

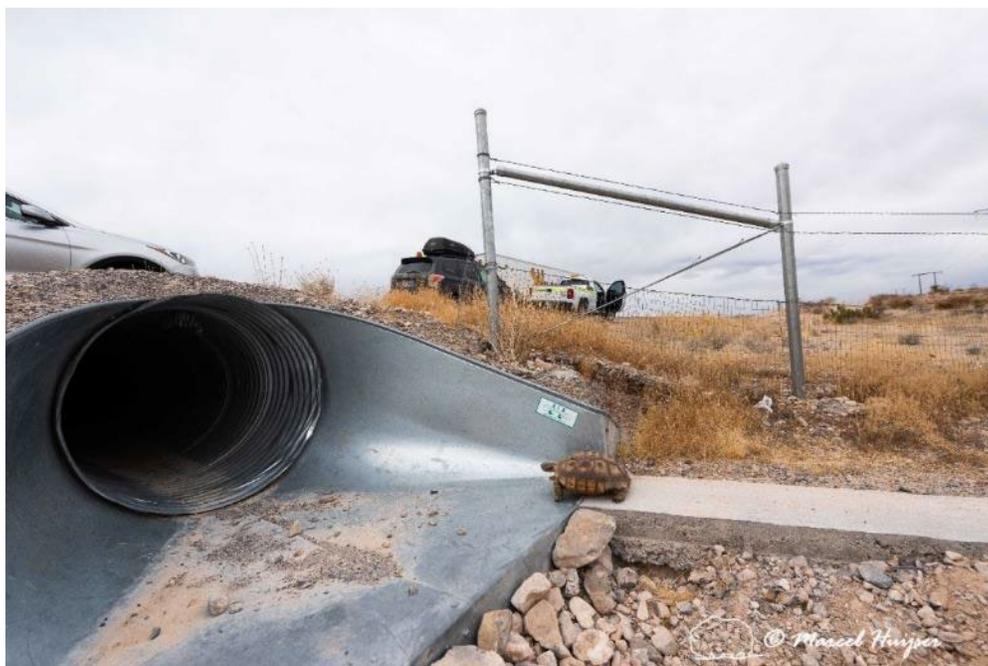
An adult tortoise model demonstrates how this concrete pathway may allow access to the culvert entrance, US Hwy 93 (MP 58 NB) near Overton, Nevada. As noted above, the drop-off at the outflow of the culvert is a potential barrier to juvenile tortoises.

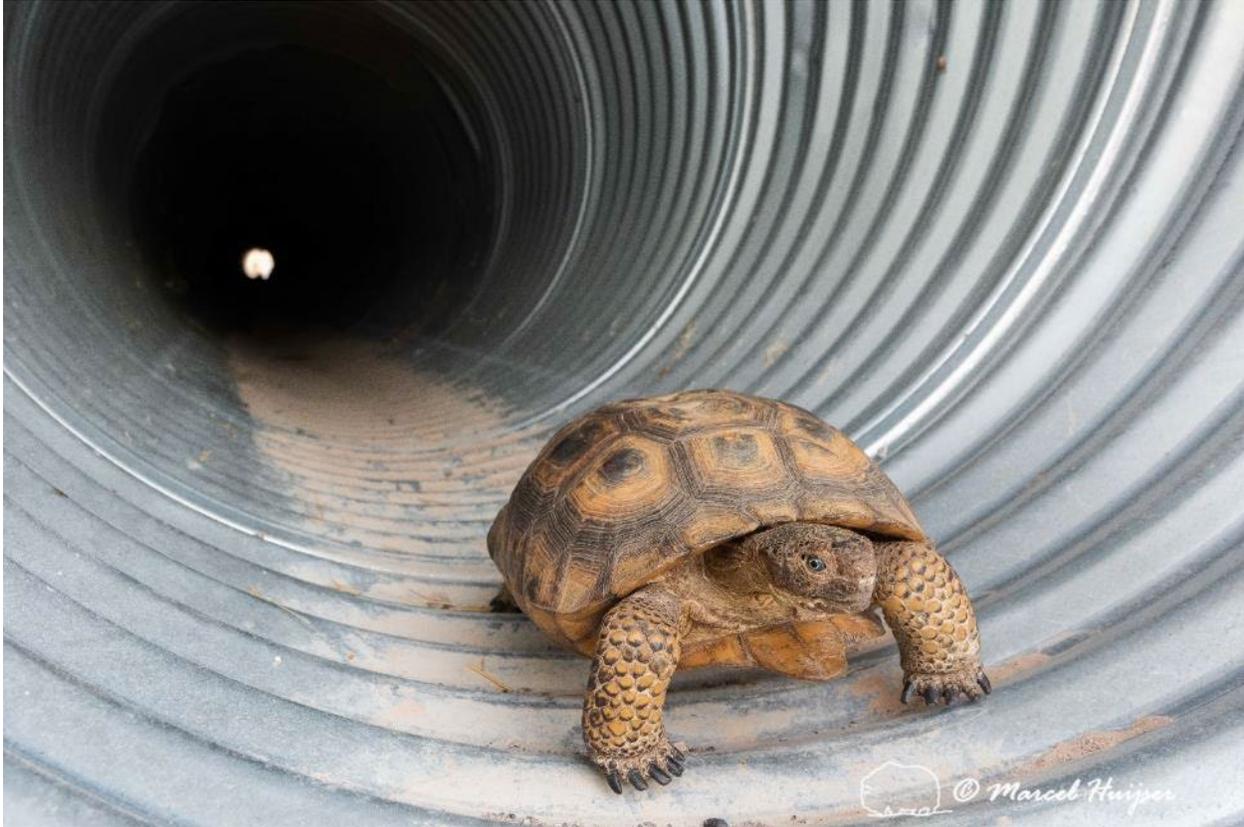
An adult tortoise model in a corrugated metal culvert (Corrugated Metal Pipe (CMP)), US Hwy 93 (MP 58 NB) near Overton, Nevada. Adult tortoises have been observed passing through these types of culvert structures, regardless of whether natural substrate was present (BLM and DCP 2022).

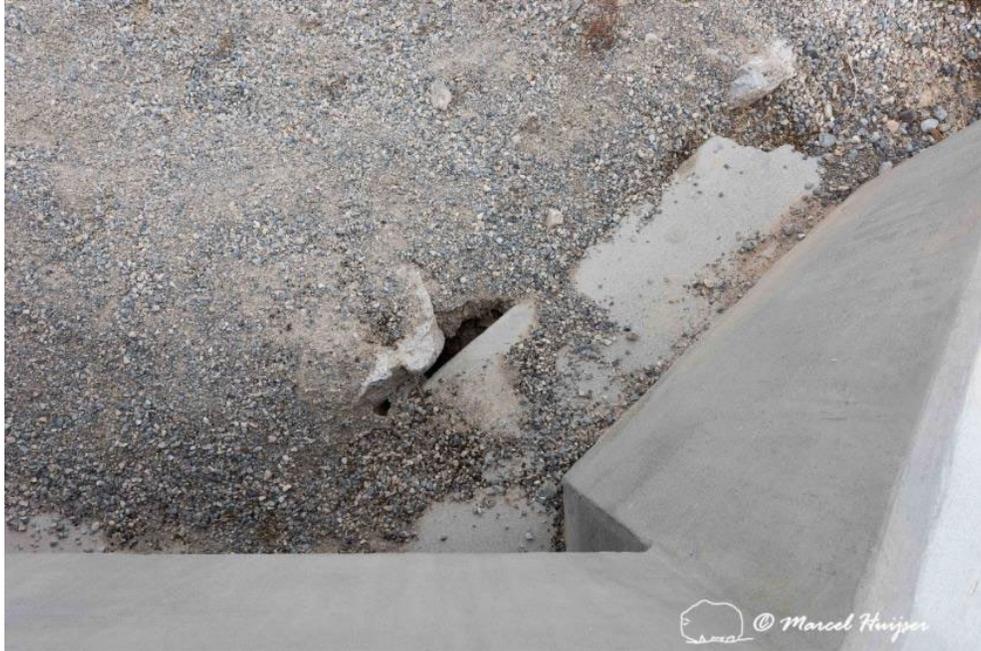
Erosion along a concrete pathway leading up to a concrete box culvert, US Hwy 95 (MP 127.5 NB) near Indian Springs, Nevada. The riprap is filled with finer sediments that allows Mojave desert tortoises to access the culvert. However, it appears that the finer sediments are washing out and resulting in cavities that could trap Mojave desert tortoises.

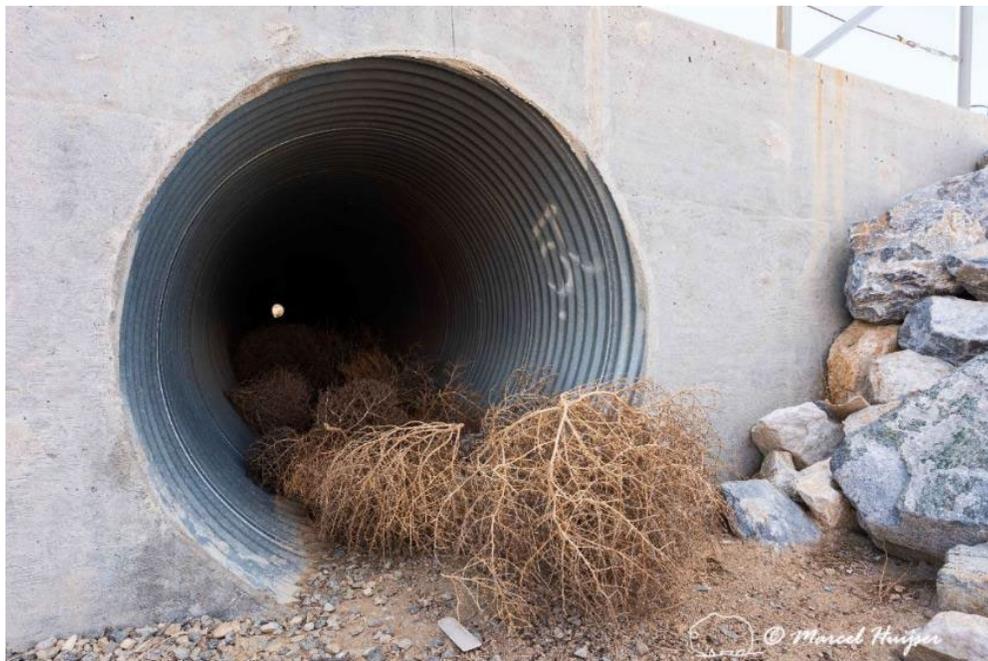
Culvert primarily constructed for hydrology, but the culvert may also allow for passage by Mojave desert tortoises I-15 near Barstow, California. However, this culvert is blocked by tumbleweed.

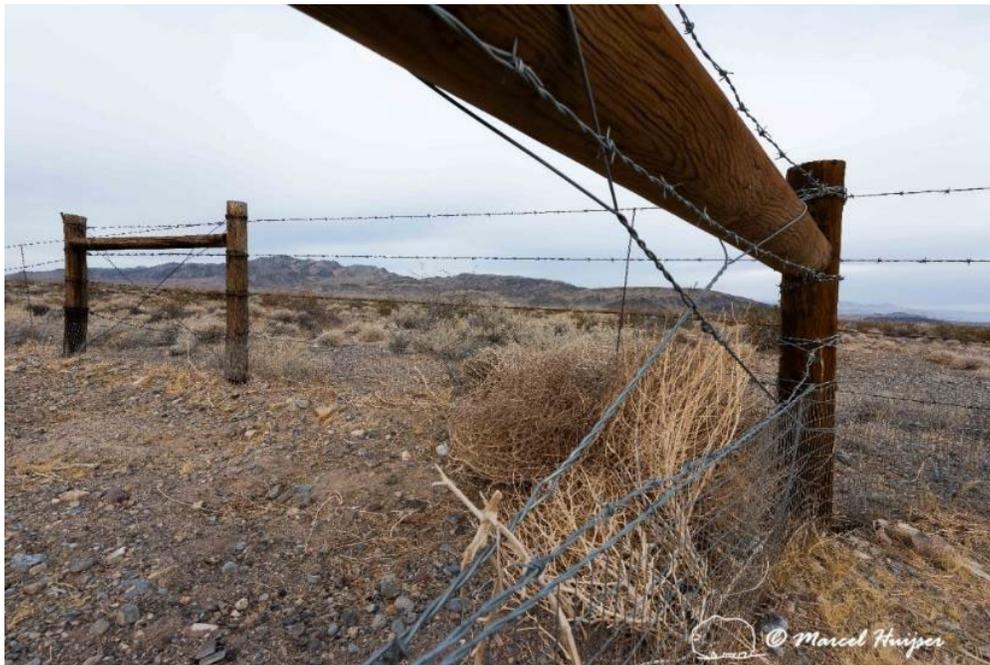
Mojave desert tortoise fence blocking access to a culvert that is considered a danger (e.g. entrapment between riprap or drowning in a deep plunge pool), US Hwy 95 (MP 125 NB) near Indian Springs, Nevada. The decision to block tortoises from accessing the culvert implies that the danger associated with accessing and using a culvert is considered greater than the benefits of potential crossings.

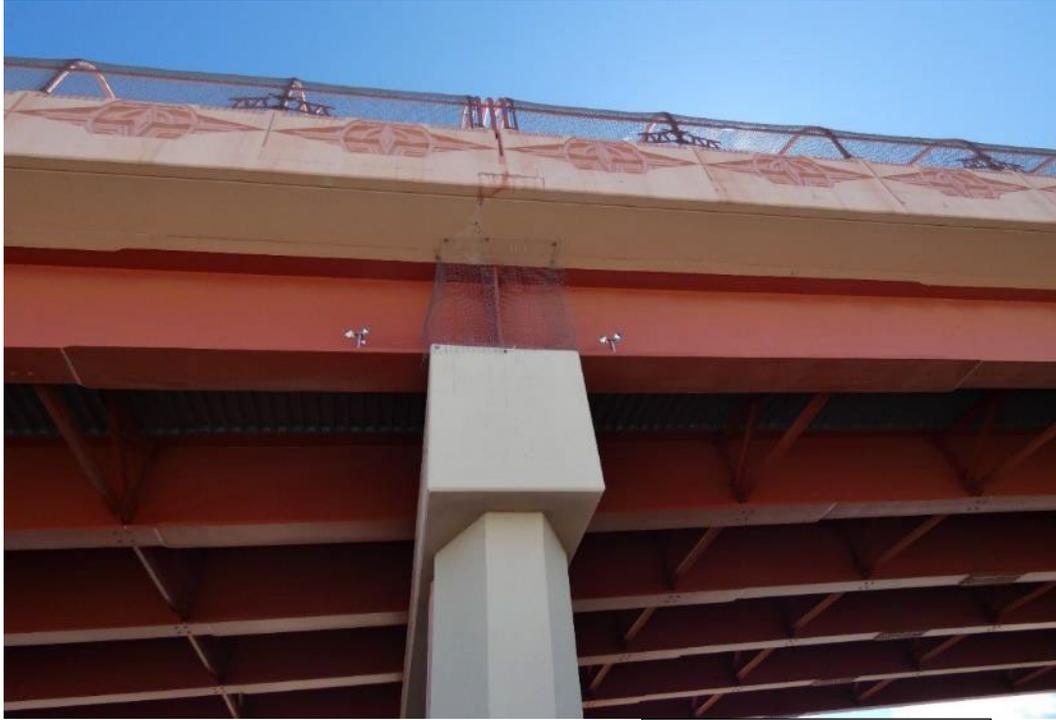
Wire mesh and metallic flashers installed to discourage raven nesting on Snow Mountain Overpass, U.S. 95, Las Vegas, Nevada.

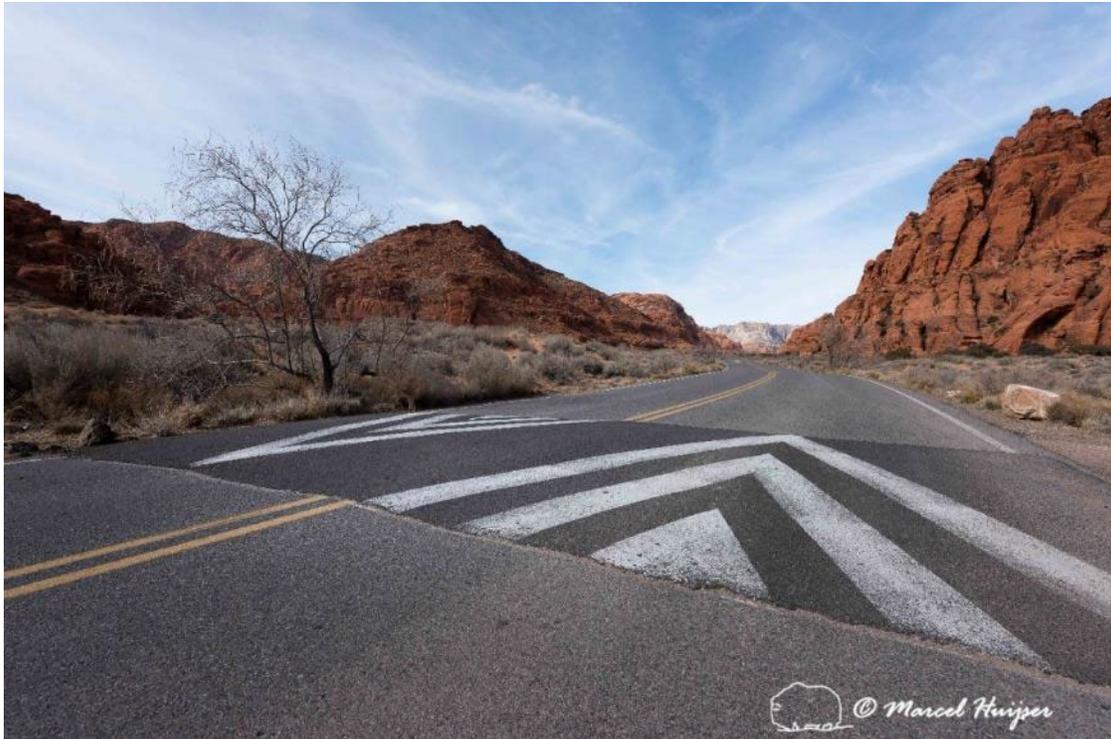
Speed bump to control speed, primarily for Mojave desert tortoise, St. George, Utah.
